Team on The Case

MNCEG March Quarterly Meeting
March 23, 2021

IEA Project Purpose- Initial Assessment

IEA Project Purpose- Roof Assessment

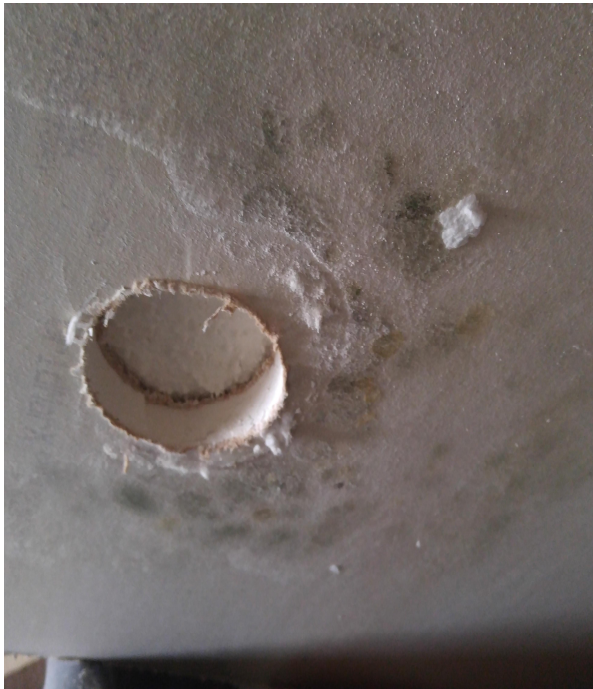
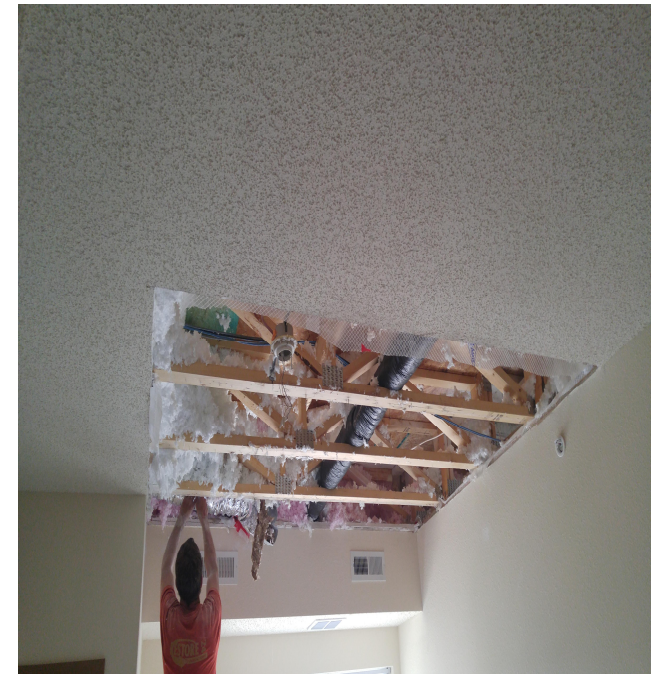
- Upper Floor Occupants concerned with fungal growth on gypsum ceiling & musty odors.
- Isolated locations – appeared to be “common” leak issues.
- Ceiling areas opened: Exhaust venting for bathrooms & dryers appeared to be source.
- Ducts cleaned/sealed and light remediation work occurred. Buttoned back up.
- Months later –issue redeveloped and was determined bigger source for issues.

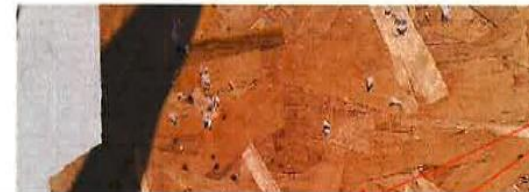
Test Cut Location A5

- IEA observed evidence of moisture intrusion, including water staining and discoloration of OSB sheathing. Moisture meter readings were 16-32%.

Discoloration
Underside of
Sheathing

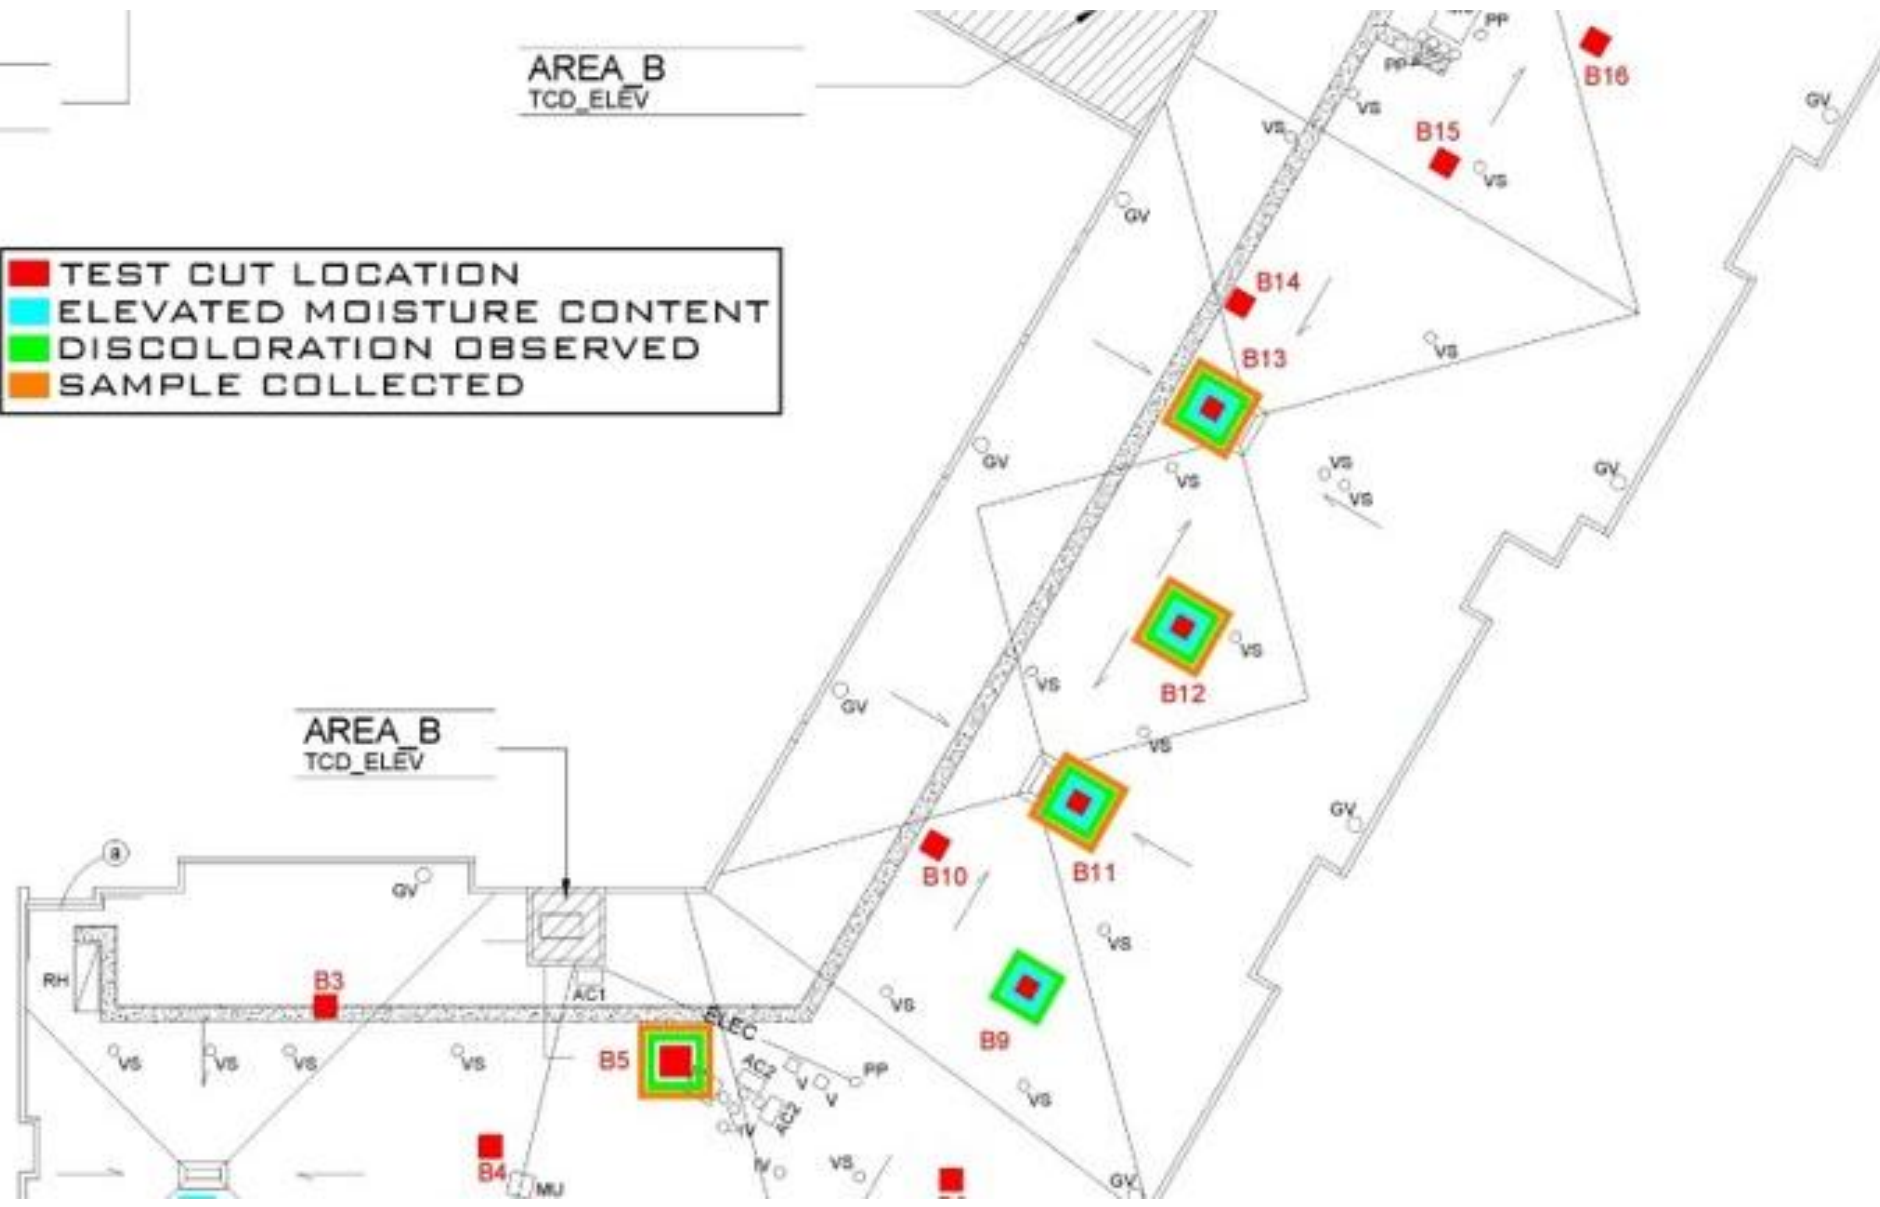
AREA B
TCD_ELEV

- TEST CUT LOCATION
- ELEVATED MOISTURE CONTENT
- DISCOLORATION OBSERVED
- SAMPLE COLLECTED
