The Benefits of a Well Maintained Building

“Proactive or Reactive:
The Cost of Masonry
Maintenance”

Pam Jergenson, CCS, CCCA, BECxP, CxA+BE
September 6, 2018

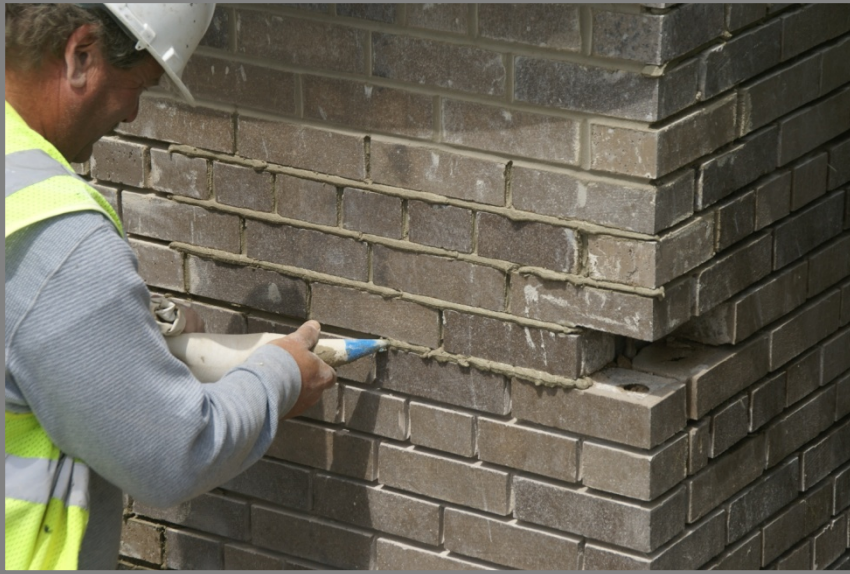
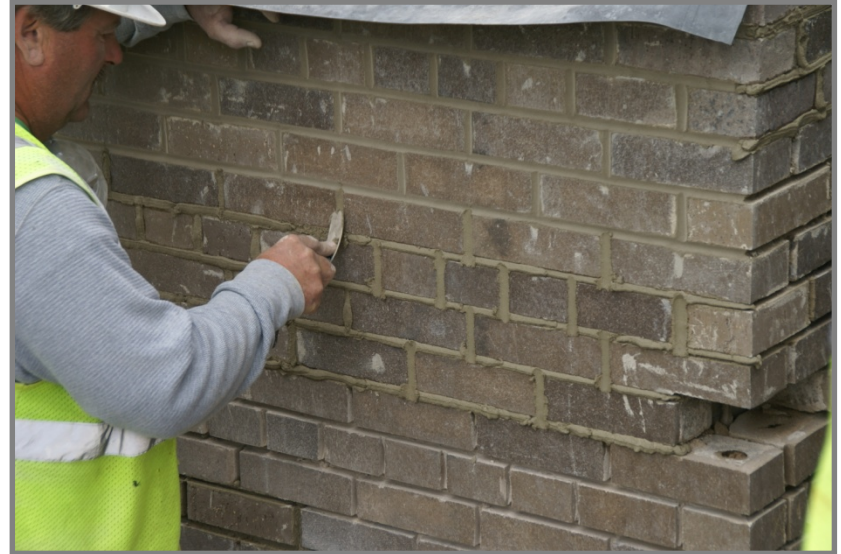
Tuck pointing or Repointing

- **Install new mortar in layers**
- **Compact between layers**

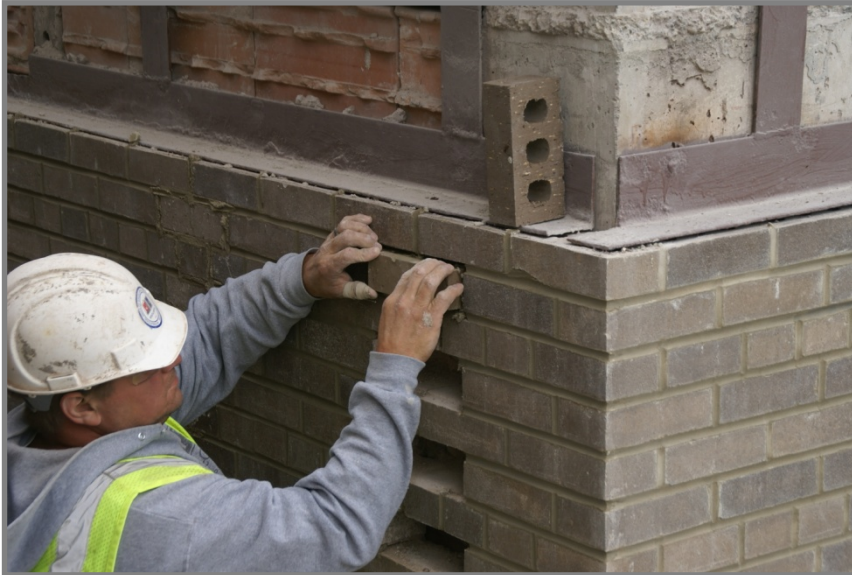
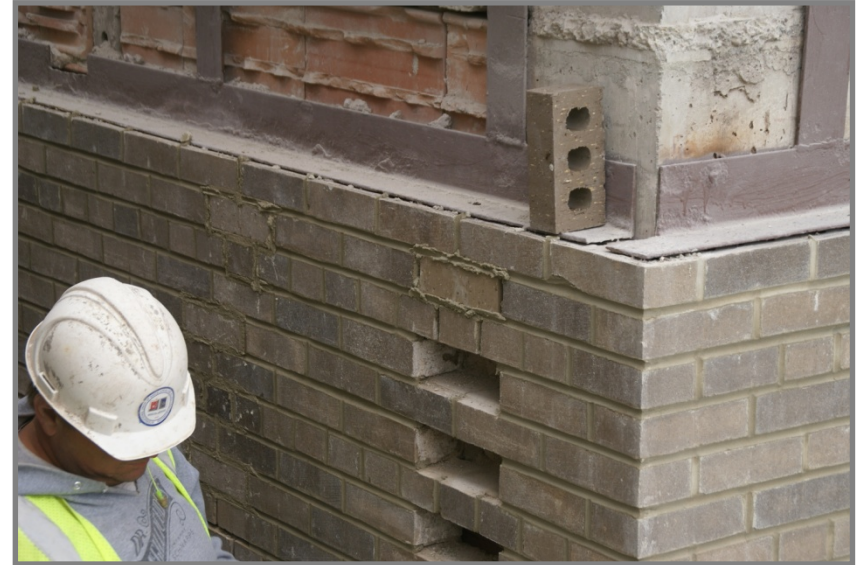
Spot brick replacement

- **“Butter” new brick and shove into place**
- **Point in mortar around new brick**

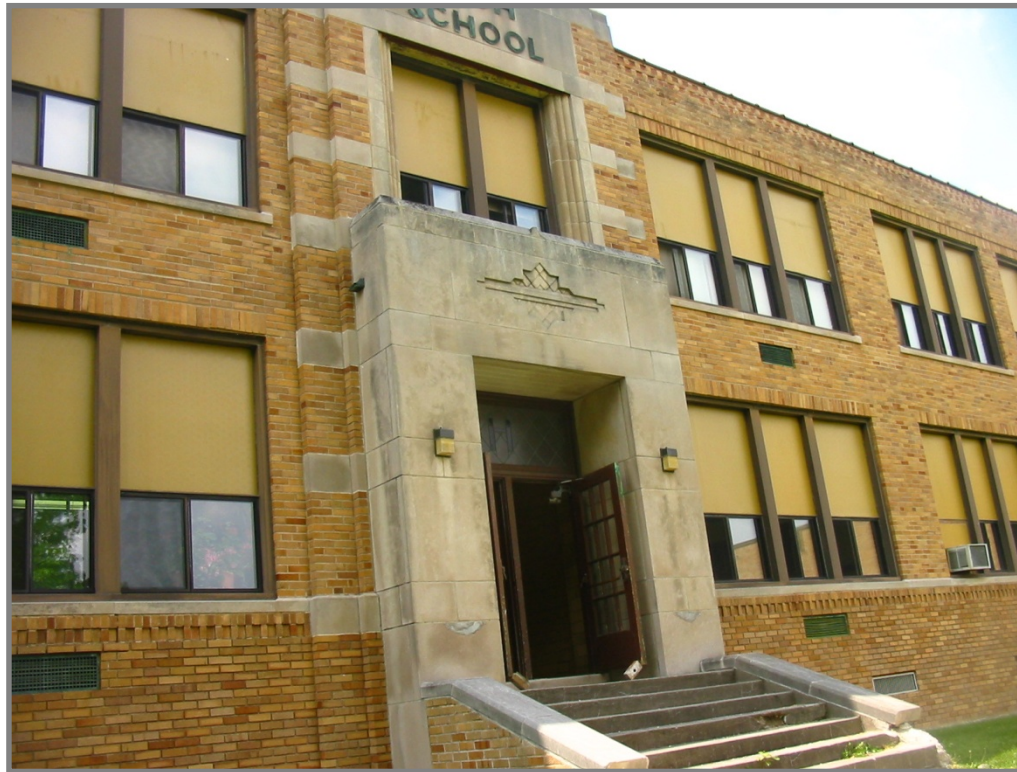
Two-story brick masonry

- Original construction circa 1937
- No recent masonry maintenance

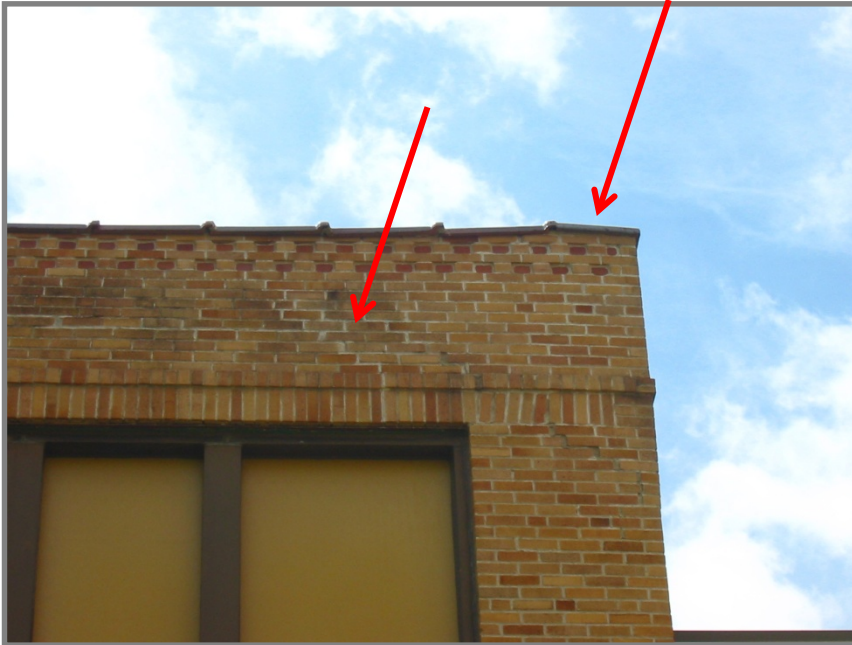
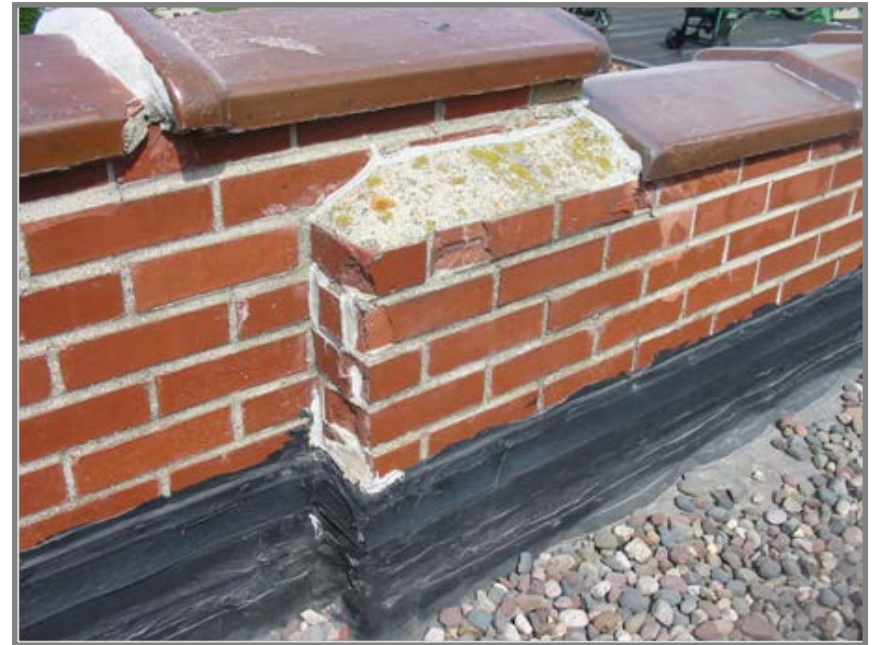
Visual observations

- **Loose coping tiles, displaced masonry**
- **Deteriorated mortar on roof side**

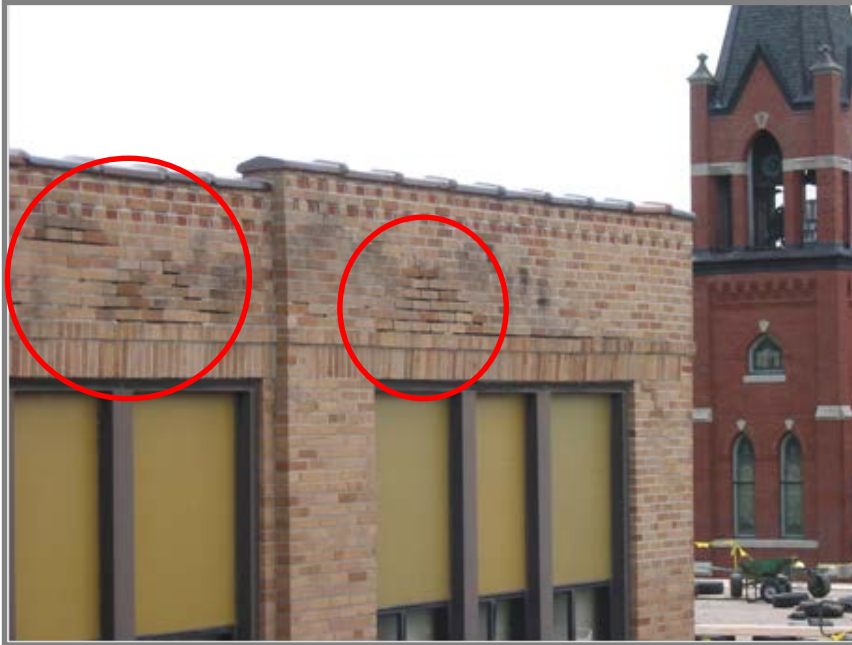
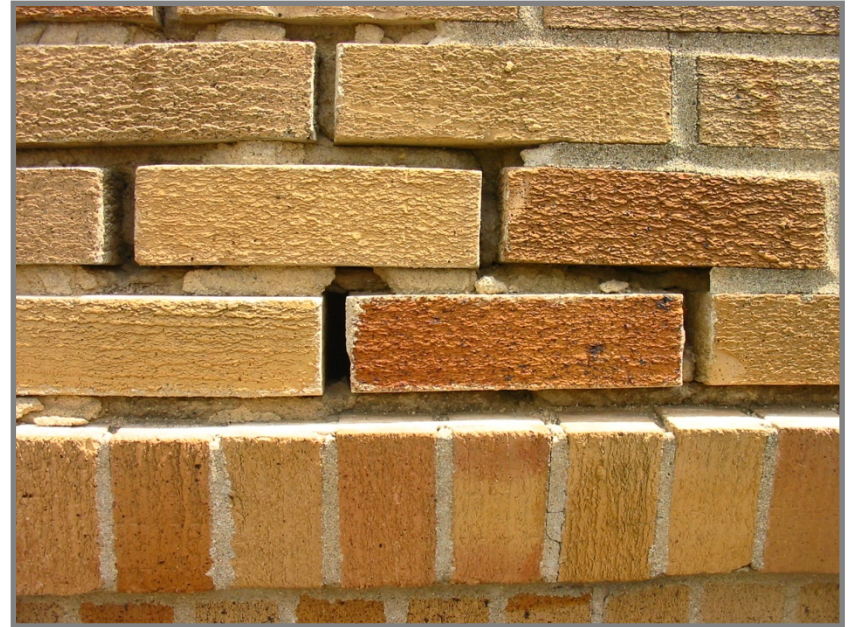
Close visual observations

- **Missing mortar**

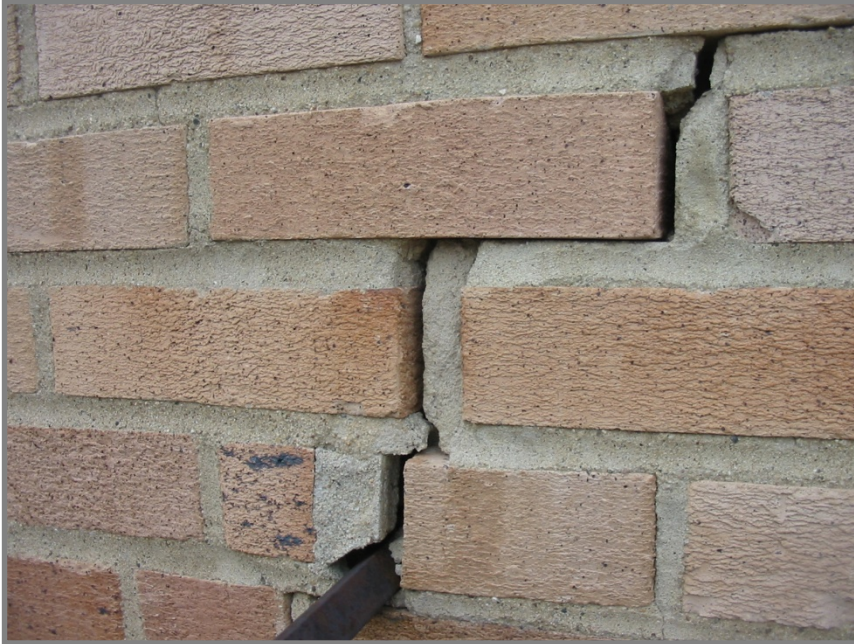
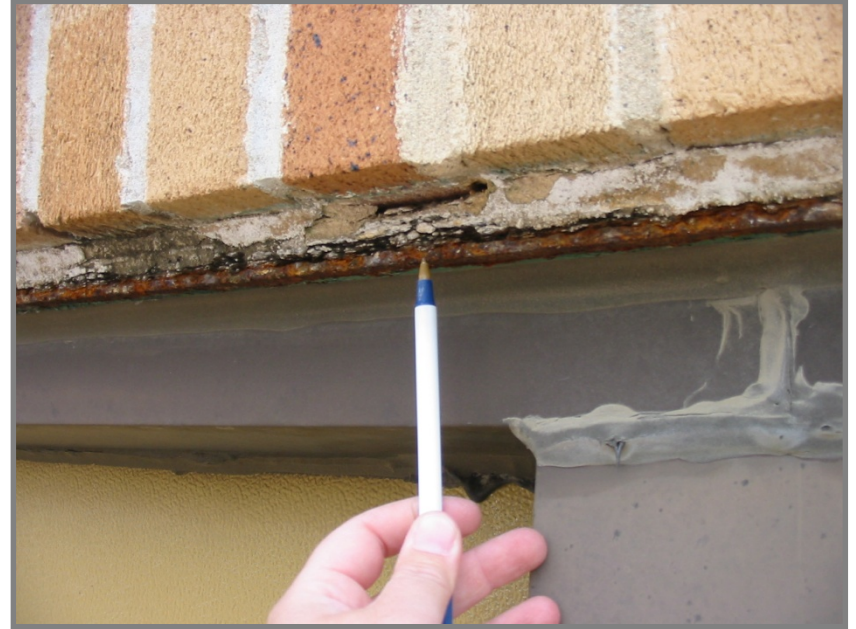
Close visual observations

- **Cracked mortar**
- **Lintel exfoliation 3/4" to 7/8"**

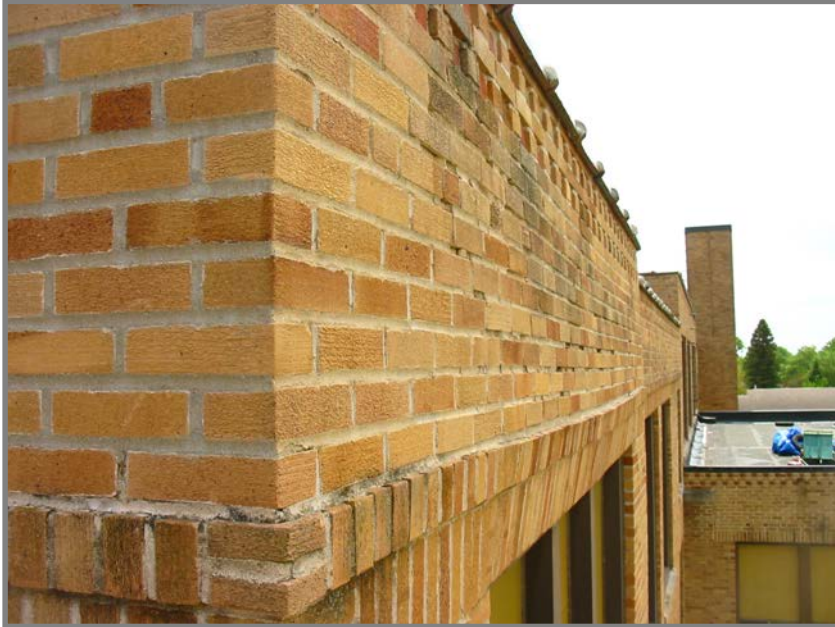
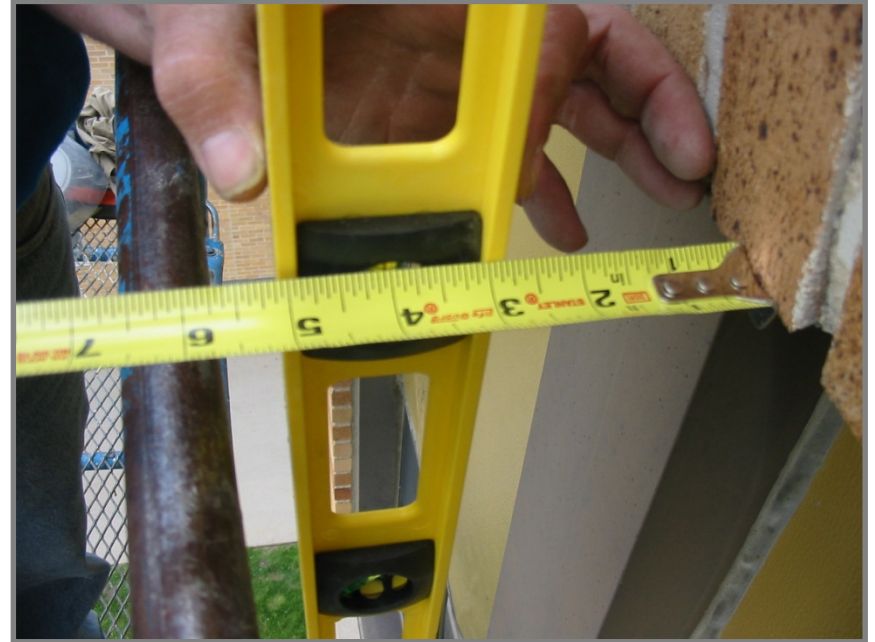
Close visual observations

- **Displaced masonry**
- **Out-of-plumb 2-3/8" in 12" height**

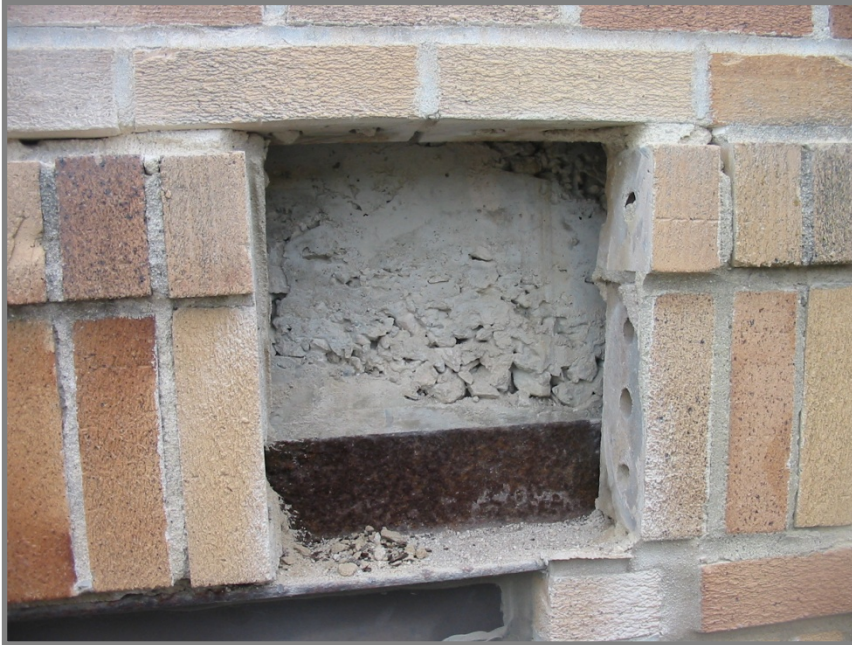
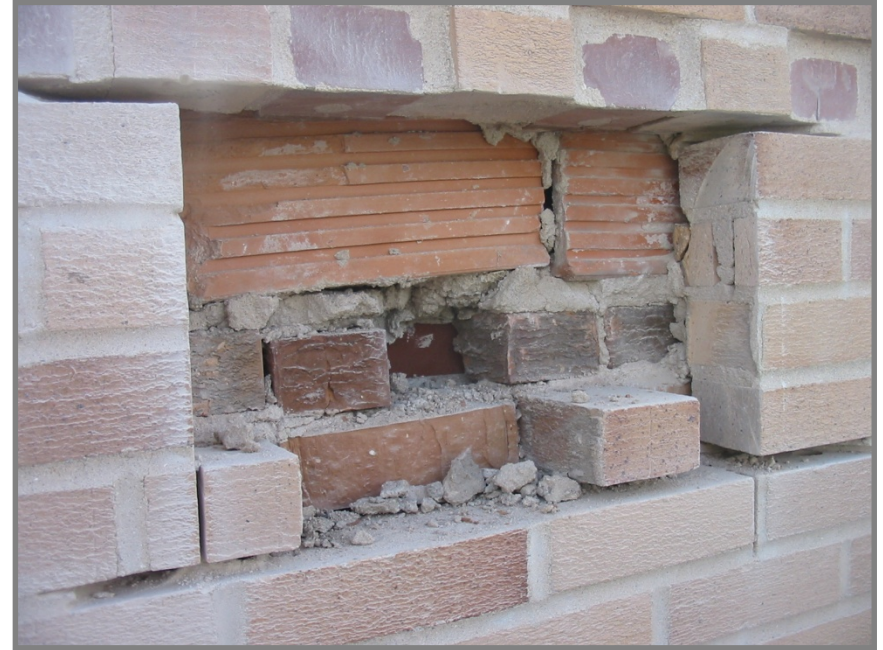
Test Openings

- **No veneer anchors for 24" above the lintel**
- **Spalled inner wythe brick and clay tile**
- **Deteriorated inner wythe mortar**

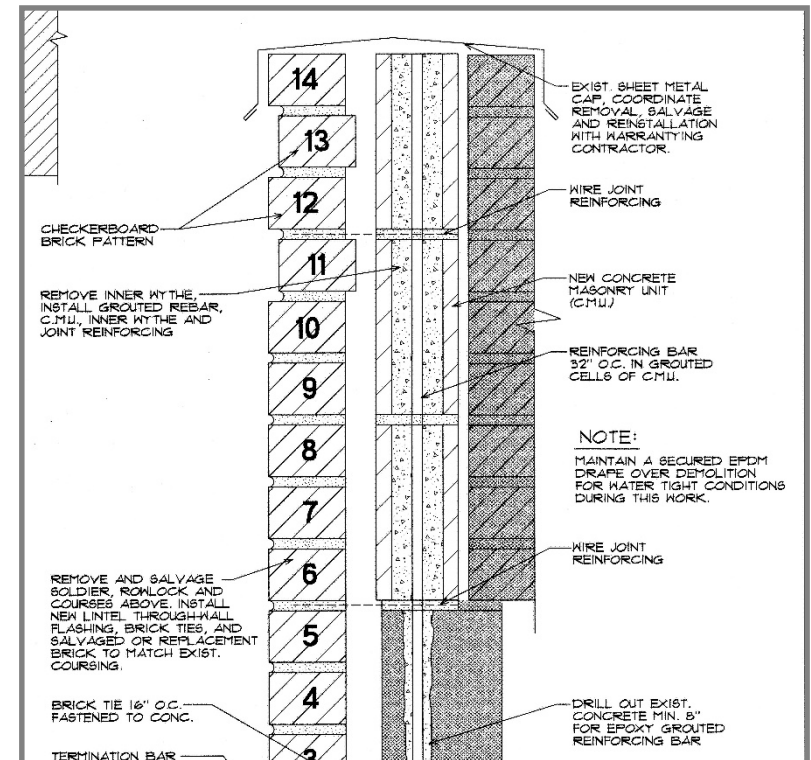
Repair Detail

- Remove exterior and inner wythes
- New lintel, flashing, veneer anchors, inner wythe, and exterior wythe

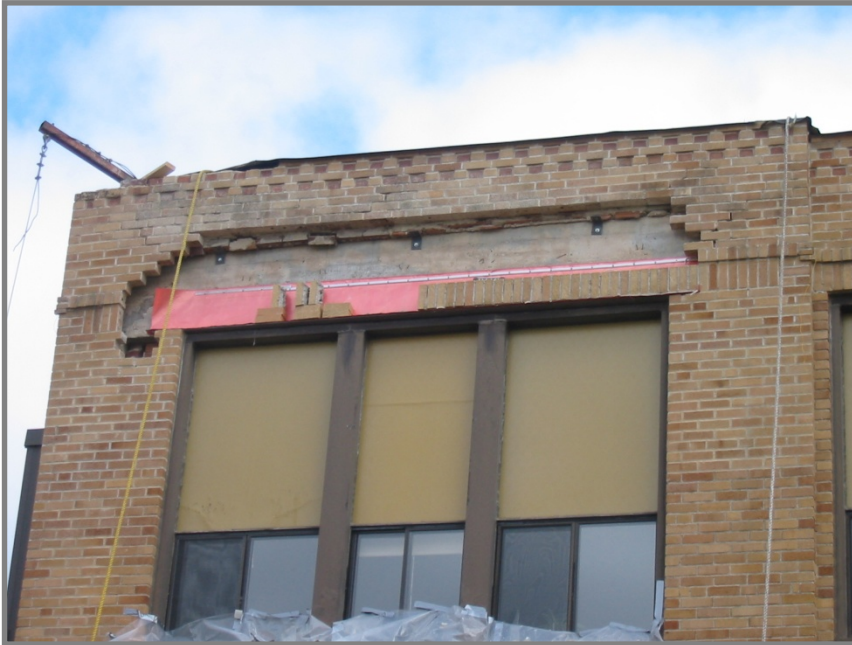
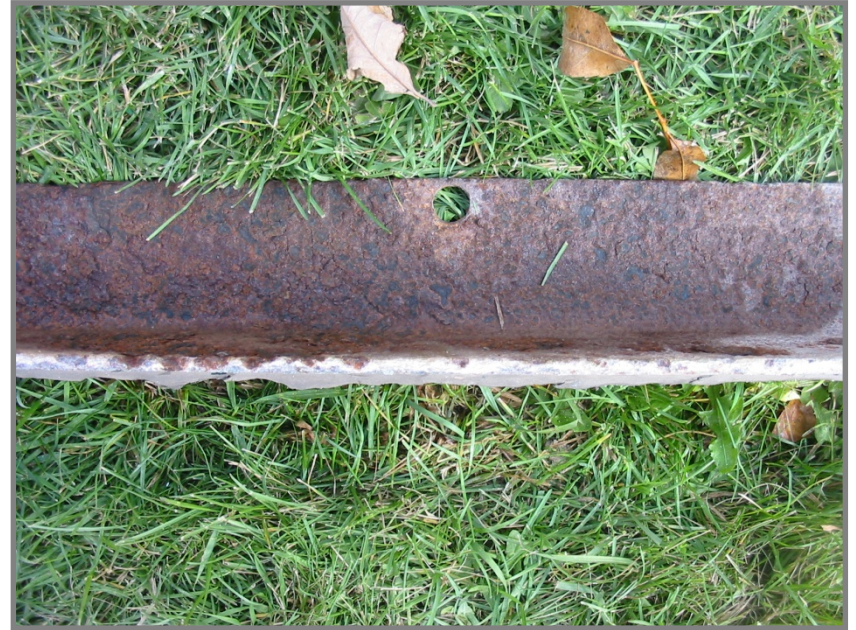
**Emergency repair for
16 foot window in 2006:
\$18,000**

2006 Emergency Repair \$1,125.00 per foot
(\$18,000 ÷ 16 ft.) of parapet

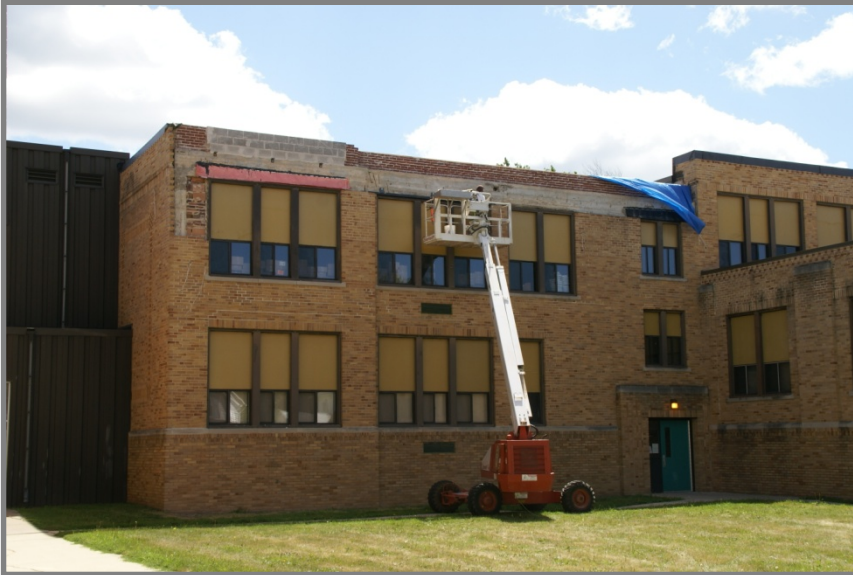
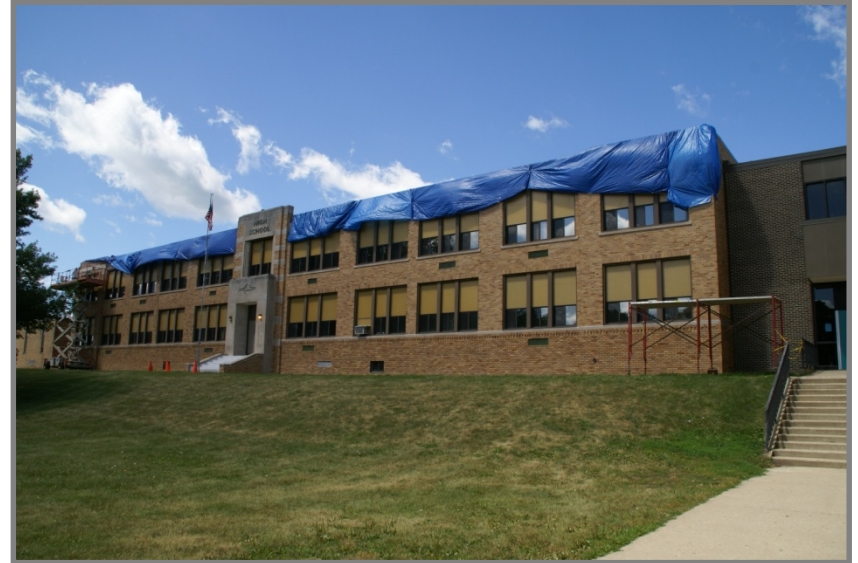
2007 perimeter repairs for 280 feet:

\$219,000

2007 Complete Perimeter \$ 783.00
(\$219,000 ÷ 280 ft.)

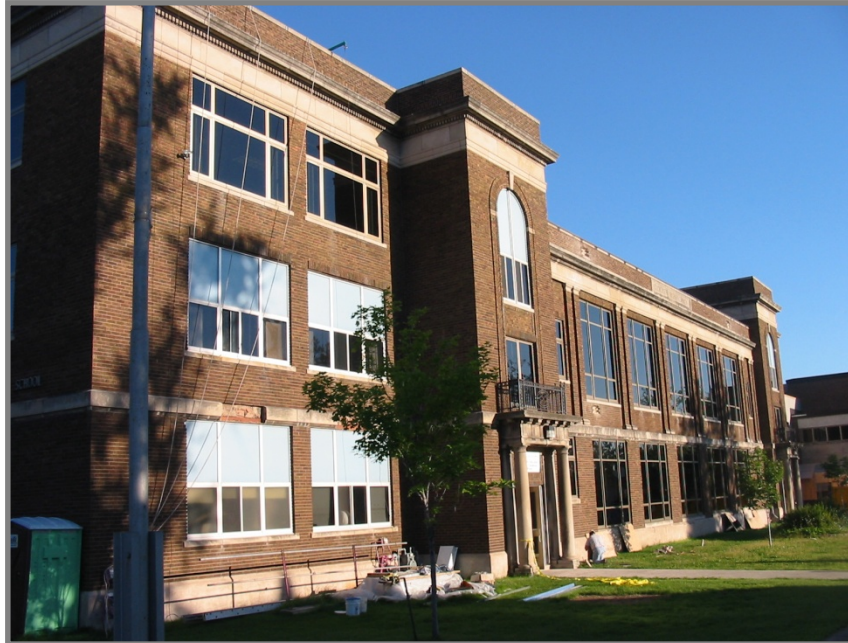
Three-story brick masonry

- **Original construction approx. 1920**
- **No maintenance records or evidence of previous maintenance**

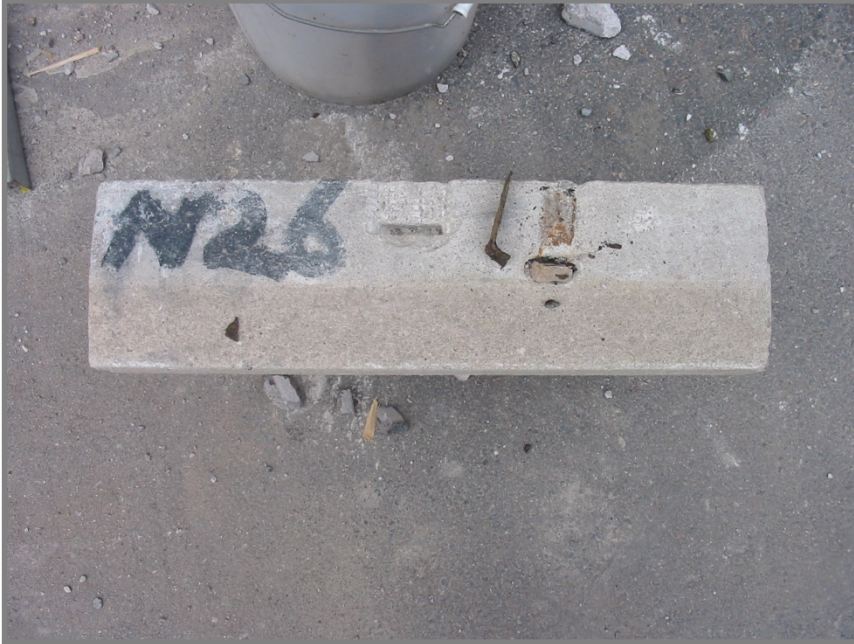
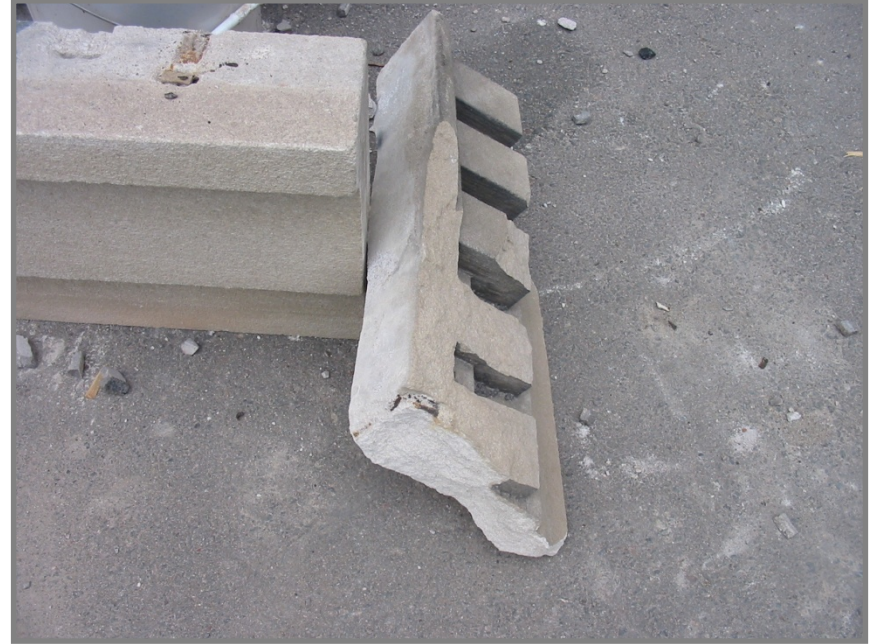
How It Started

- Tuck pointing project underway
- Stone fell into worker's hands
- Rusted stone anchors, if any present

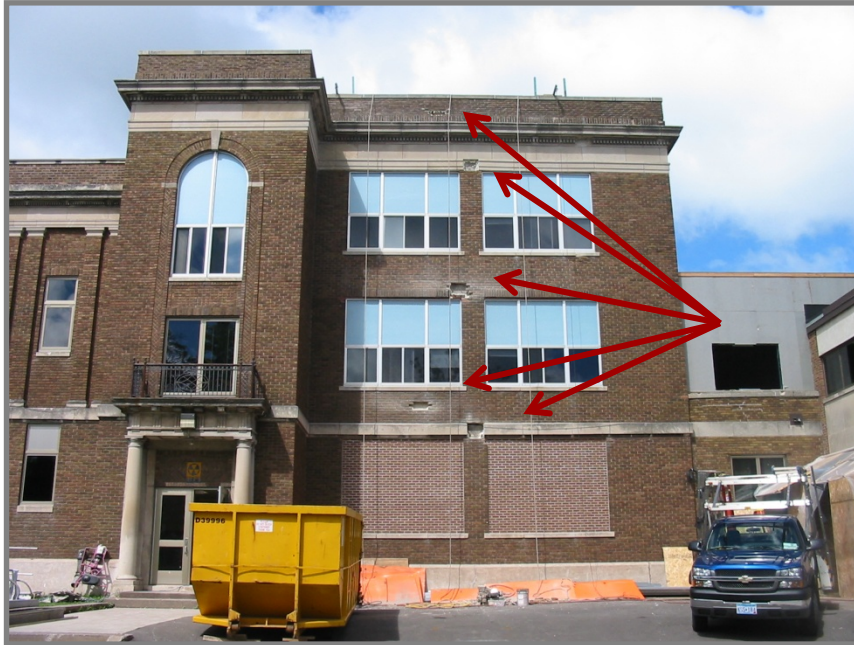
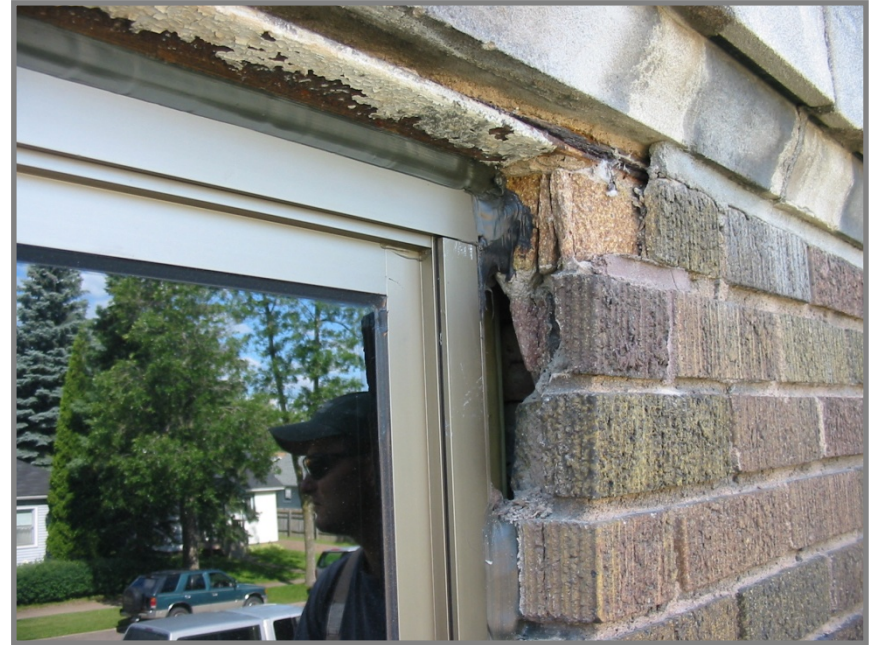
Façade Inspection

- **12 drops or vertical passes**
- **46 test openings**
- **Close observations**

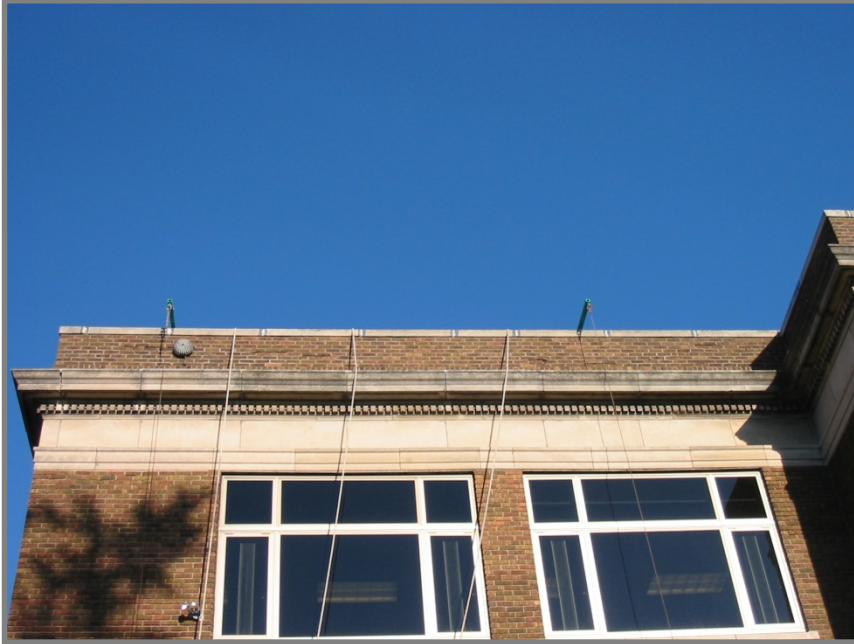
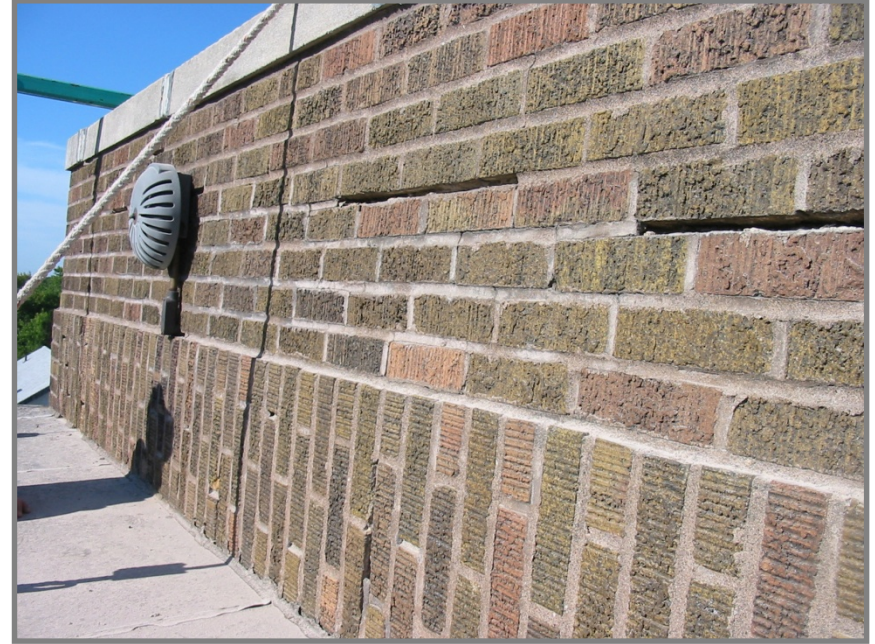
Close Observations

- From grade versus close-up

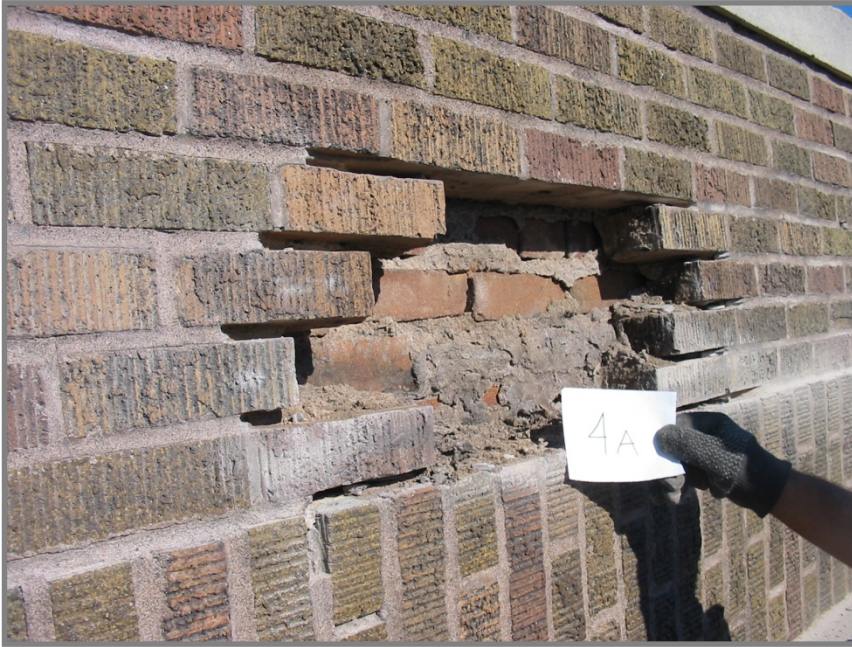
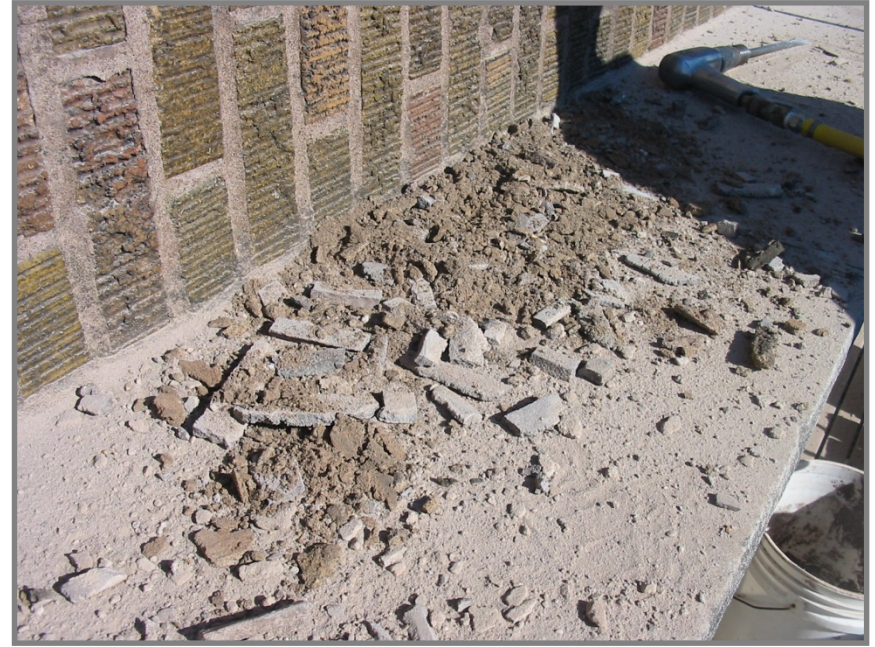
Inspection Openings

- Damp and deteriorated inner wythe
- No ties in 4 of the 10 parapet openings
- Rusted ties in 5 of the 10 openings

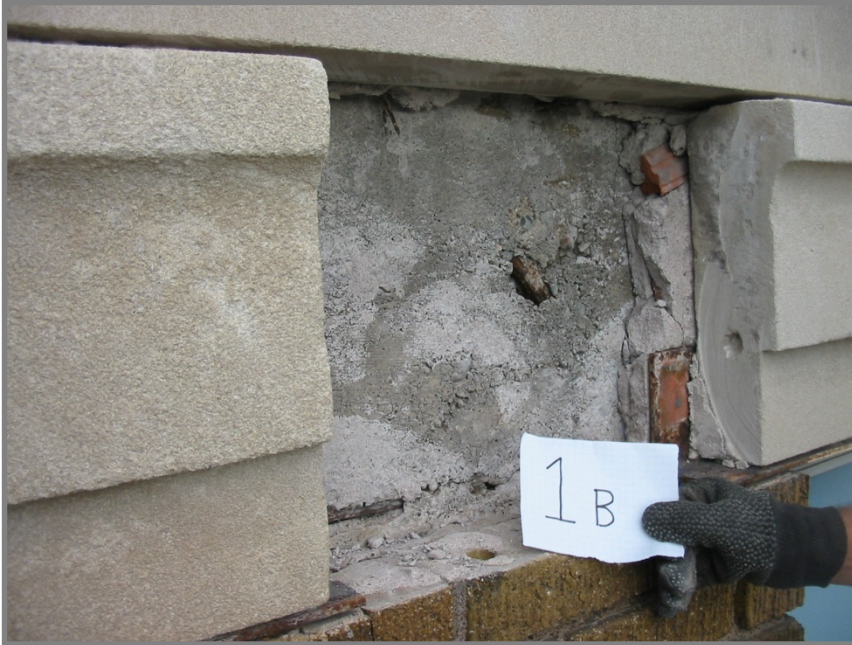
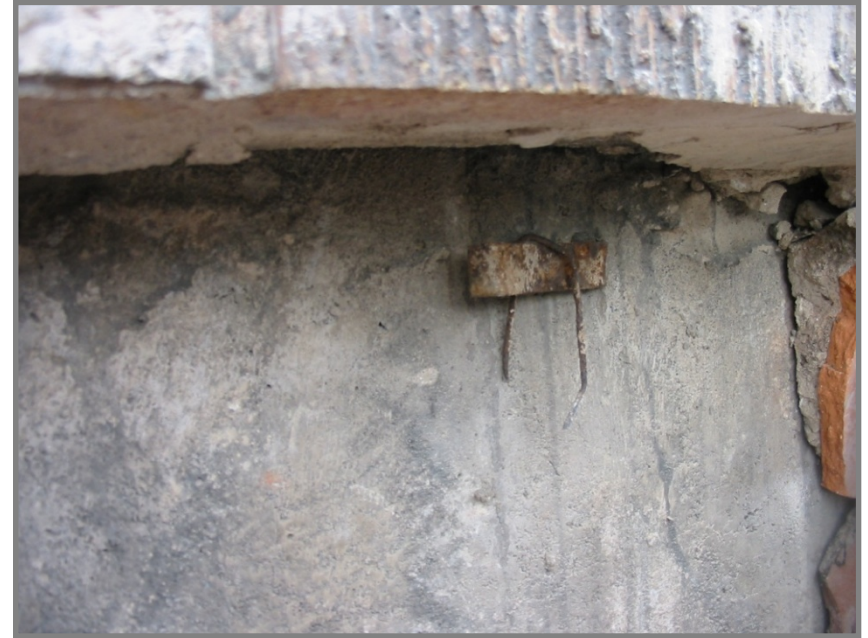
Inspection Openings

- Rusted ties in 3 of the six stone openings
- Light surface rust on the ties of the remaining openings

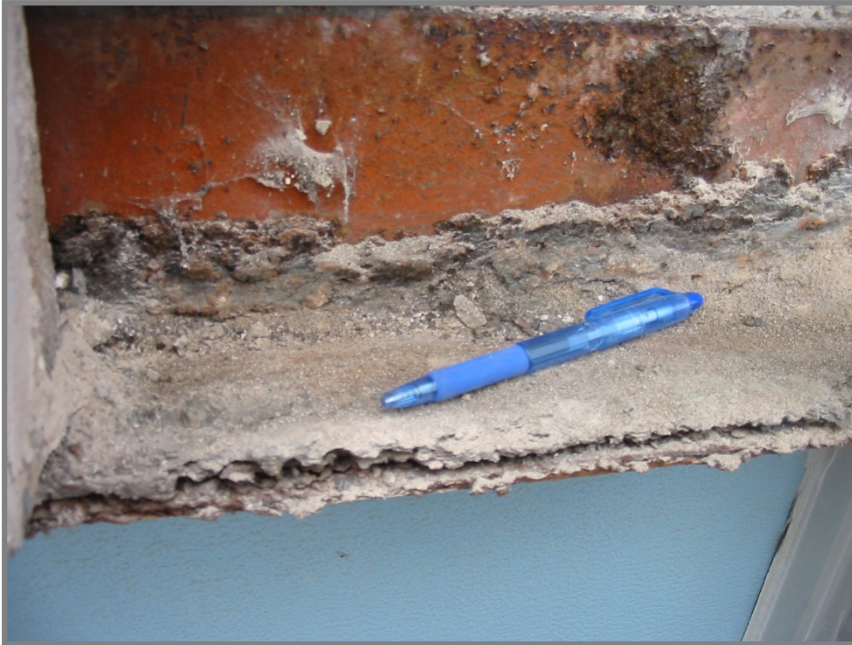
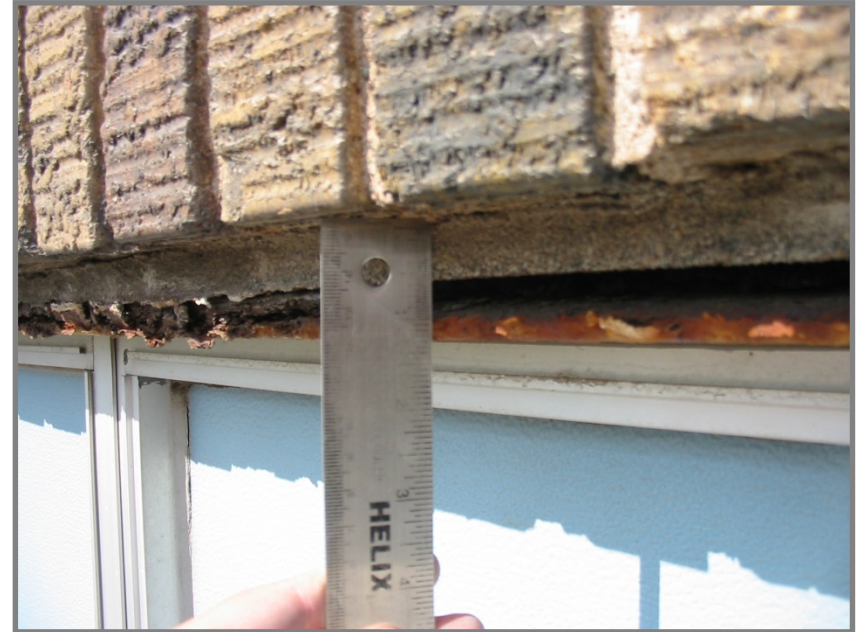
Inspection Openings

- **Hard pack rust on east and north elevations**
- **Deflected lintels at several locations**

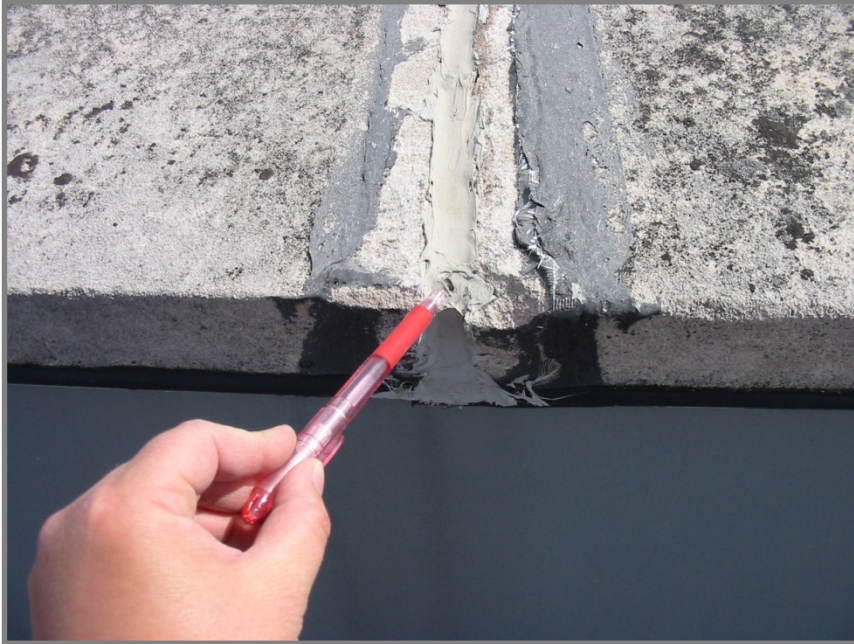
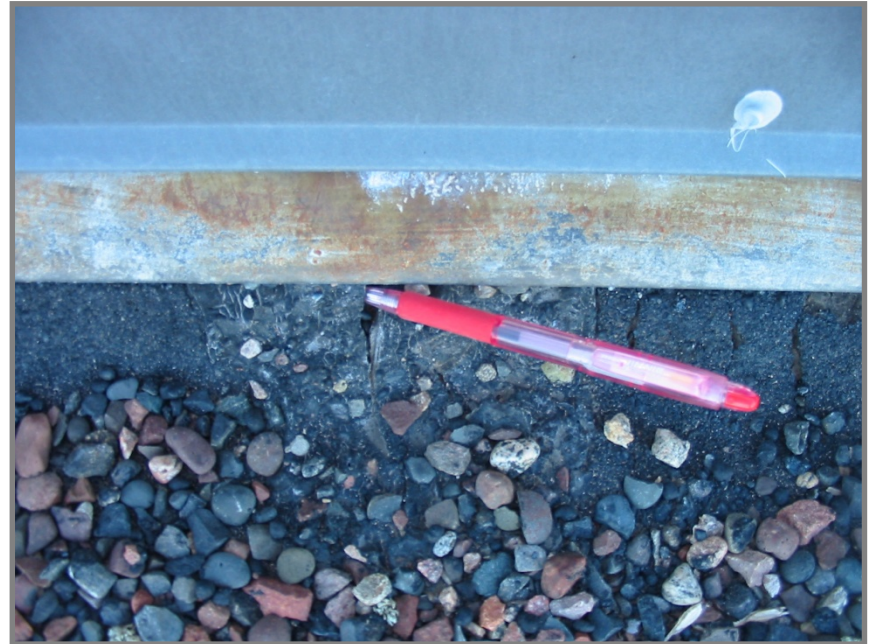
Other Observations

- **Deteriorated joint sealants**
- **Open roof base flashings**
- **Both had asbestos**

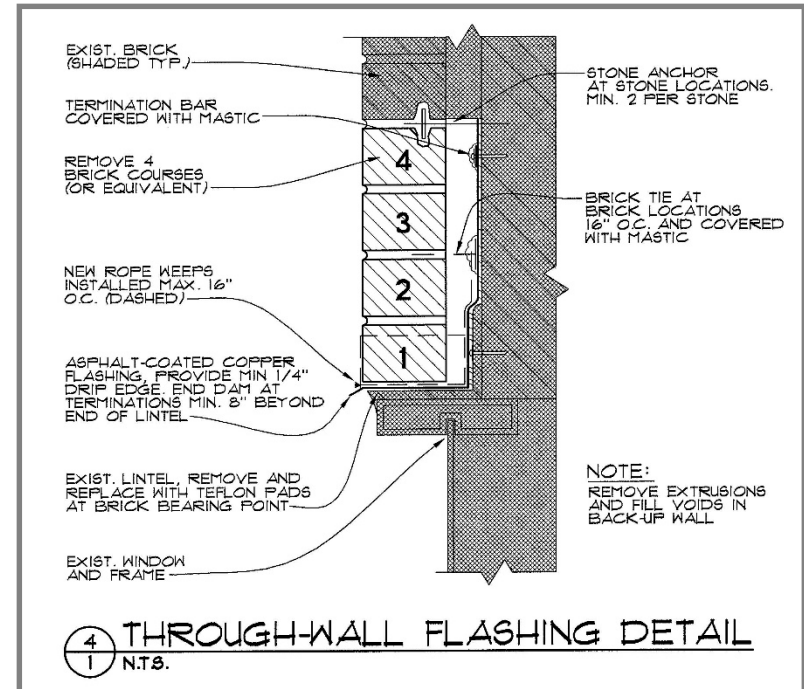
2004 Repair Details

Also: re-anchor stone, rebuild inner wythe, and replace wood joist ends
