# **MN Chief Engineers Guild March Quarterly Meeting**

# **The Case of the Rotting Roofs**

**March 23, 2021**

**Michael D. Remington, P.E.**

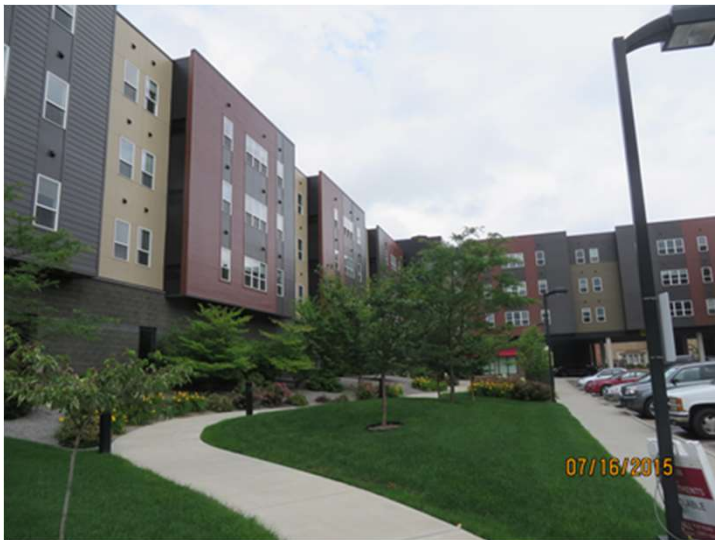
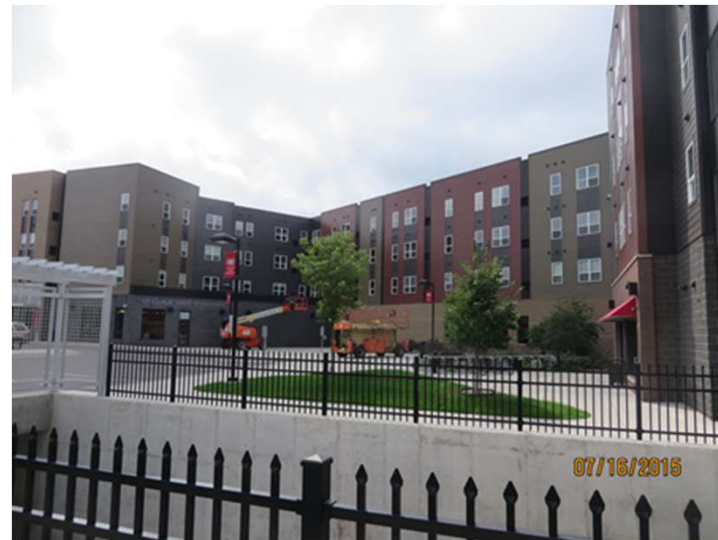
- **Three Multi-Family Residential Buildings in Minnesota**
- **Less Than 10 Years Old**
- **Low-Slope Non-Ventilated Roofs**

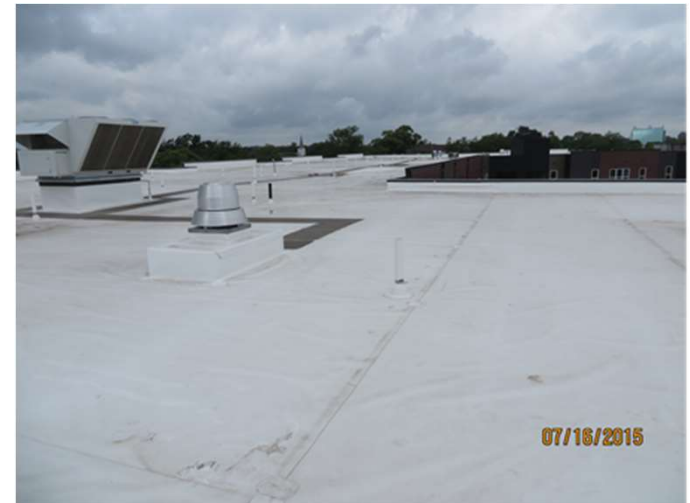
- **Blown-in fiberglass or cellulose insulation filled the truss space from ceiling to bottom of roof deck**
- **Oriented Strand Board (OSB) Installed over Trusses as Roof Deck**
- **Roof Membrane on Top of Deck**

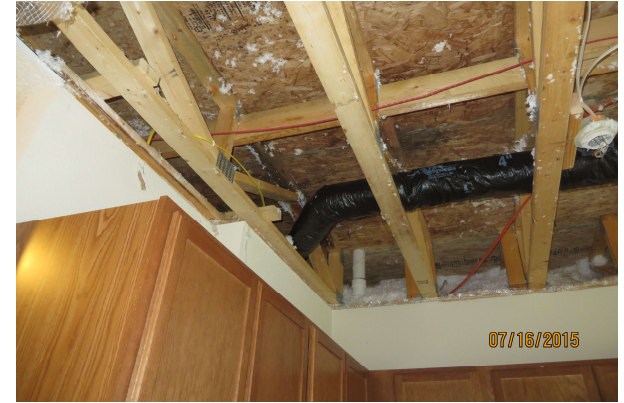
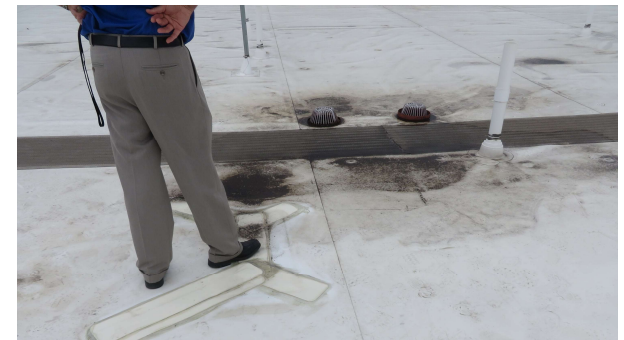
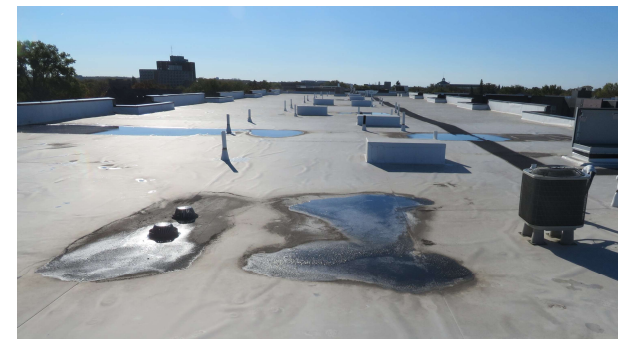
- **Building Occupants Reported Musty Odors and Concerns About Mold**
- **Maintenance Staff Walked the Roofs and Reported Soft Spots**
- **No Signs of Water Intrusion were Observed or Reported**

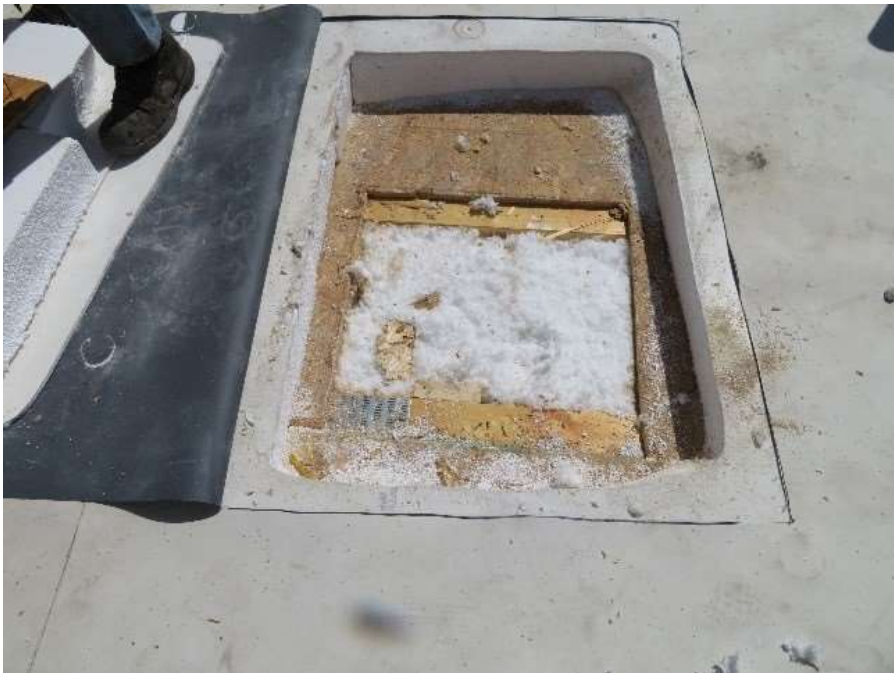
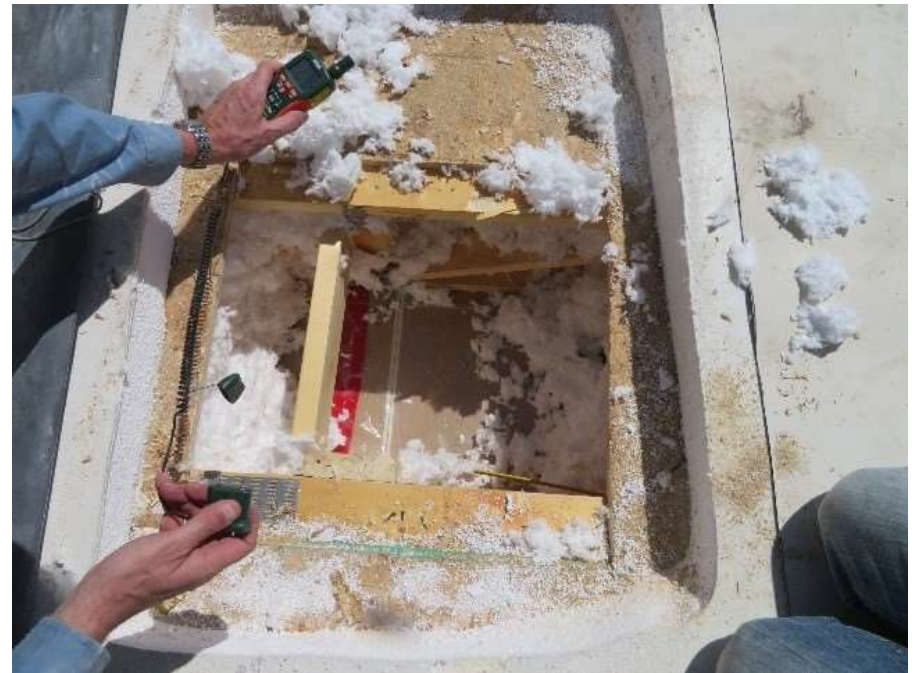
## Invasive Test Openings, Cut Into Roofs

- **Top Portion of Top Chord of Wood Trusses Were Wet and Rotting in Places**
- **Steel Tie Plates on Trusses Were Corroded**
- **Framing Lumber at Exterior Walls Was Wet**

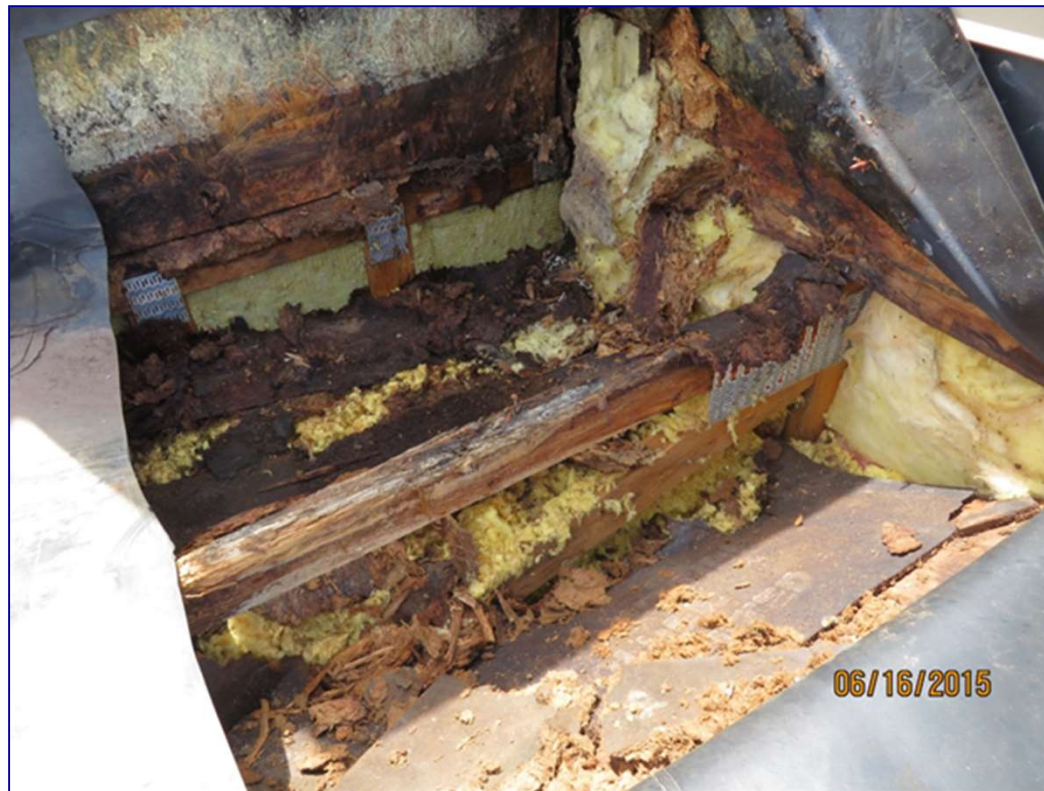
**Roof Trusses and Roof Deck Severely Deteriorated in Many Areas**

- **It was apparent that warm moist air was travelling through the many bypasses in the vapor retarder from the interior of the building up into the unheated attic space.**
- **This warm moist air was then, at certain times of the year, cooled below its dew point and condensed, resulting in significant amounts of water forming in this space.**
- **This moisture was then causing the rot and corrosion of building materials in this space.**

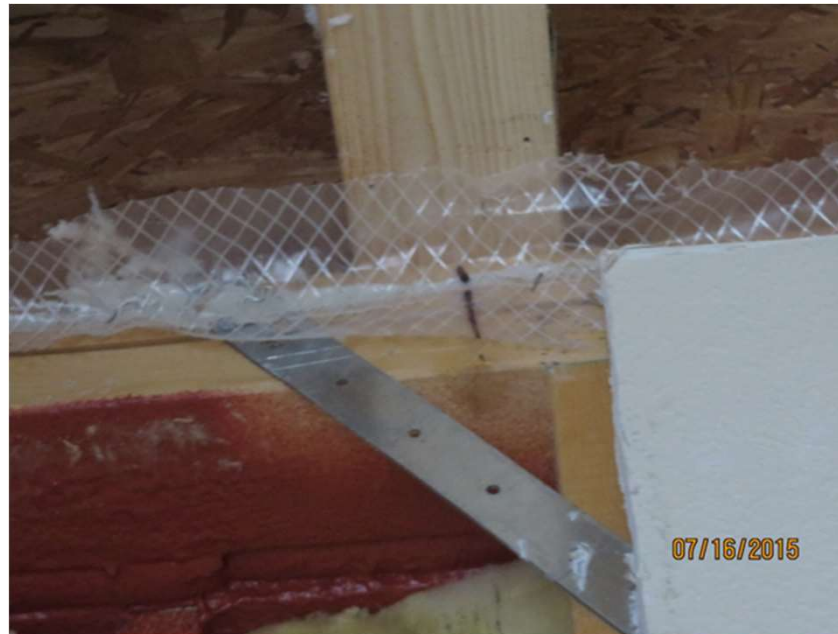
- **Walls Between Units Interrupted Continuity of Vapor Retarder**

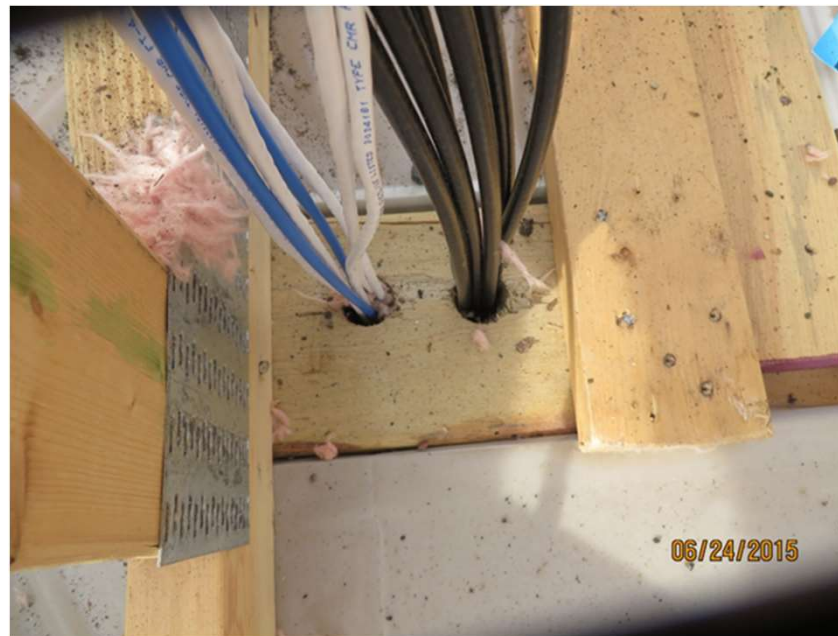
- Penetrations Through Top Plate of Walls for Plumbing and Electrical

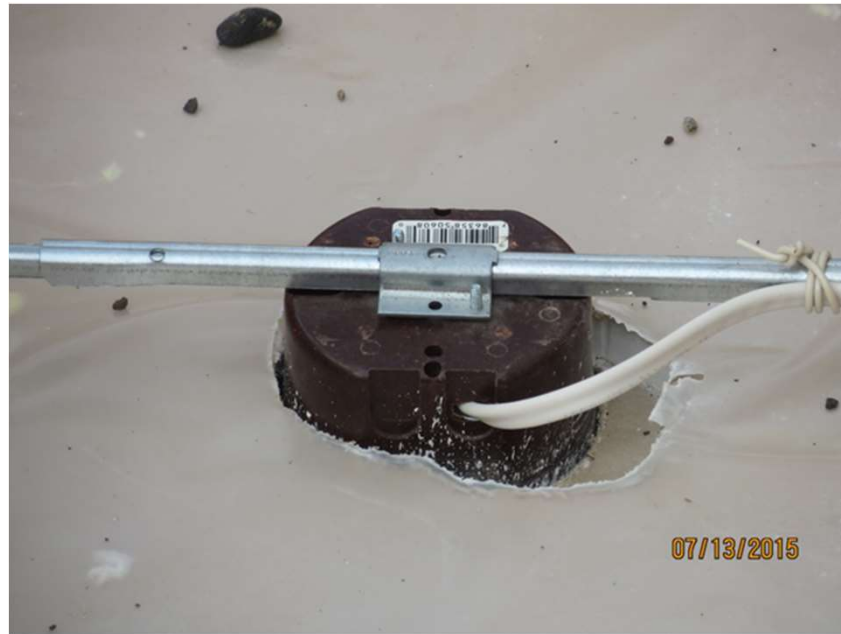
- Penetrations Through Ceilings for Fire Protection, Electrical Boxes, etc.

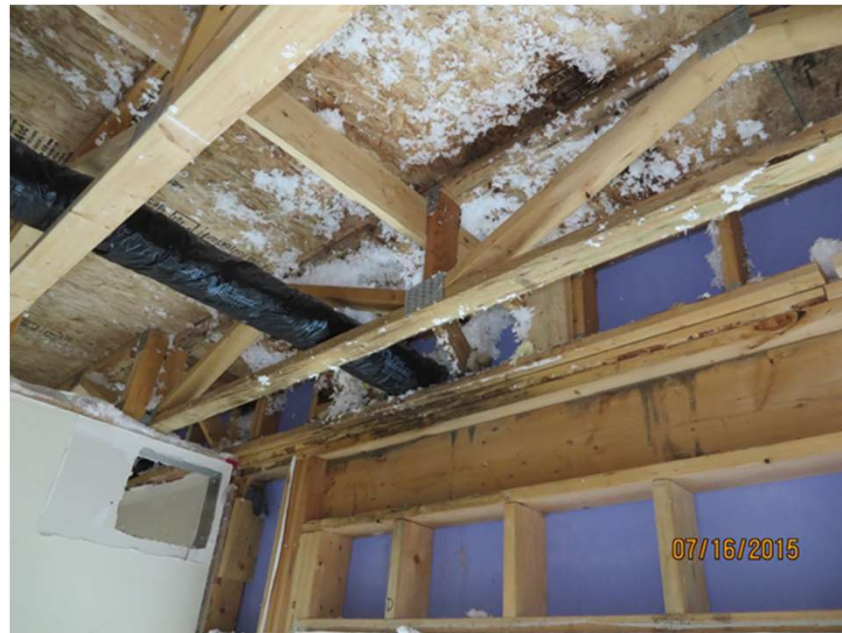
- **Ductwork from Dryer Vents and Bathroom Vents Not Properly Sealed in Many Locations**

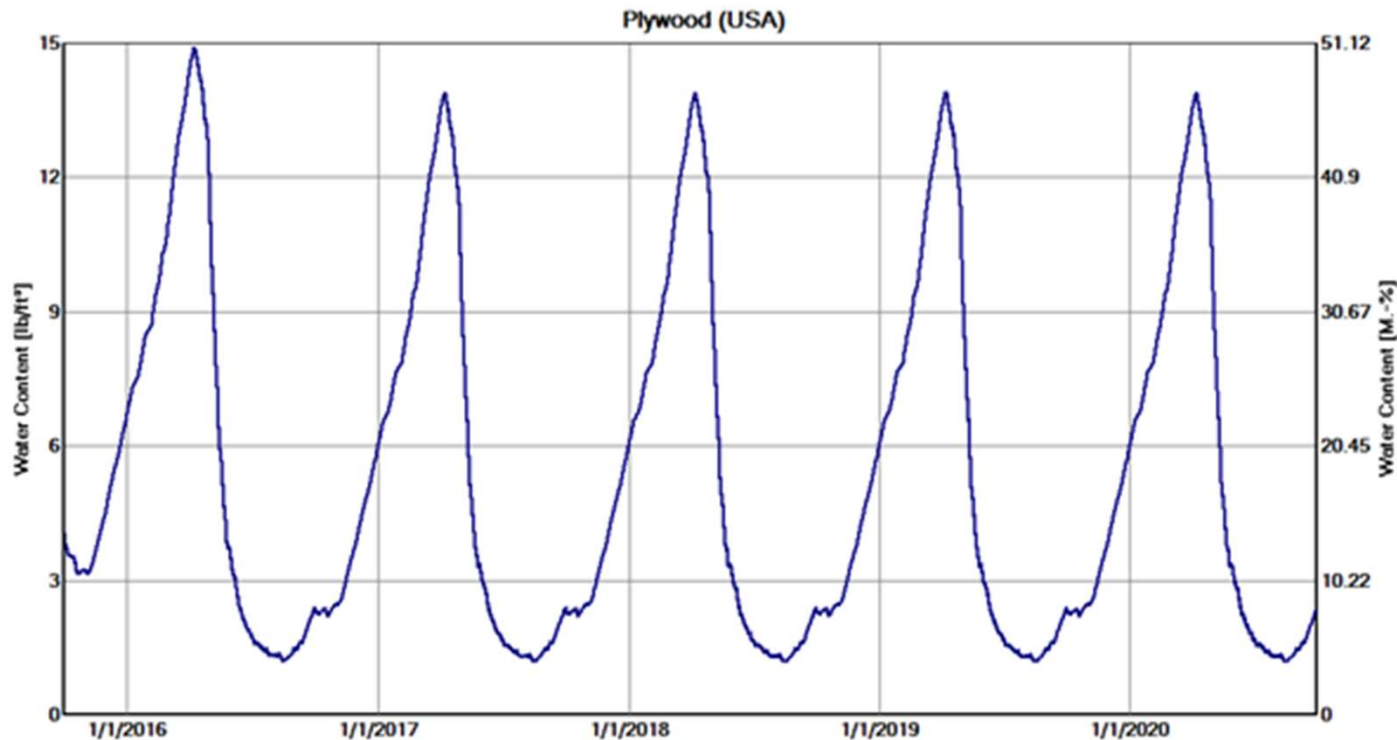
## Hygrothermal Modeling of Existing Roof System

- Shows Moisture Content of Roof Deck at 19% for About 40% of the Year Peaking in April.

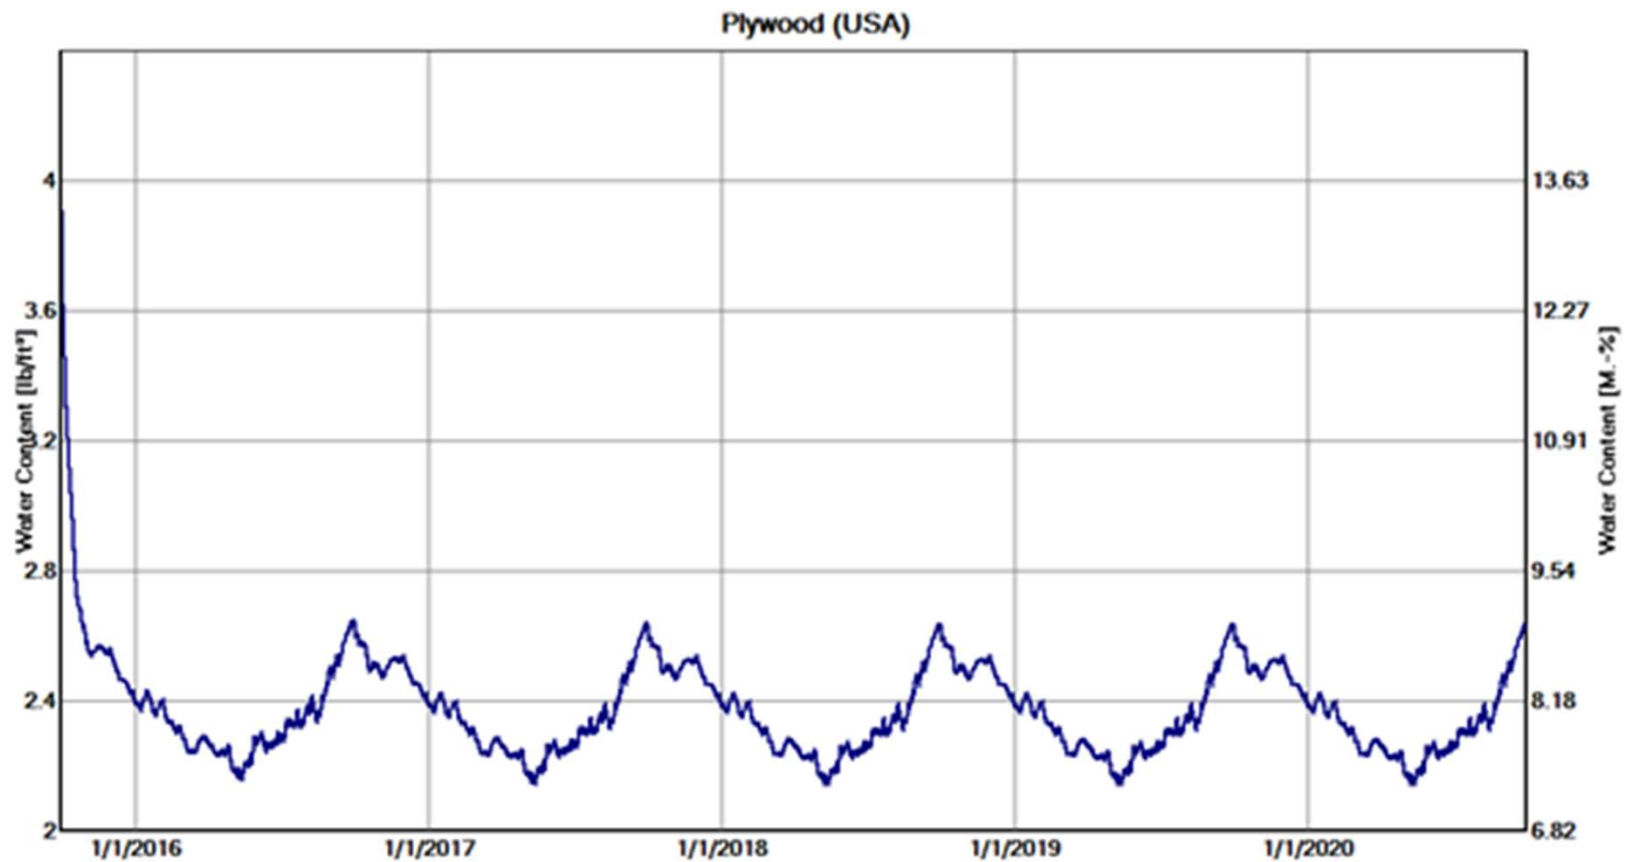
- **Hygrothermal Modeling of Option 2**

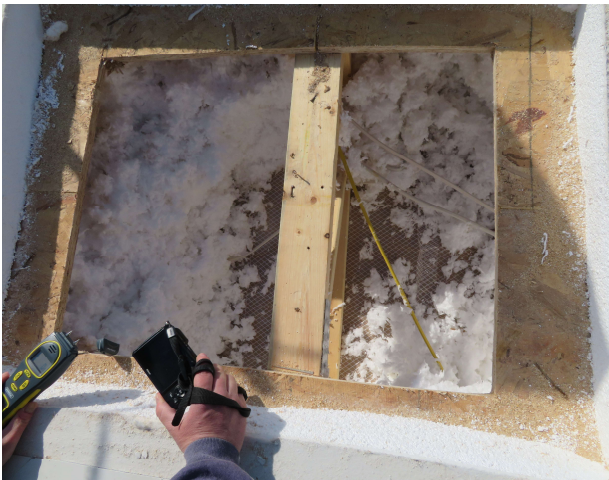
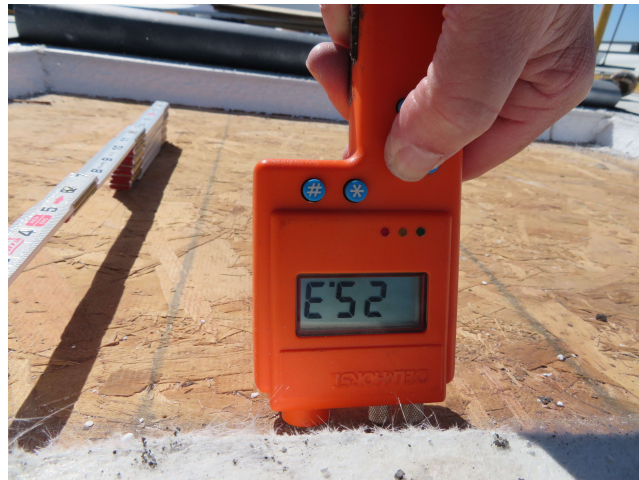
- **Design/Construction Challenges**
  - Determining damaged areas and acceptable areas of decking and insulation
  - 60 test openings, performed prior to construction to test for moisture content, damage, and mold.

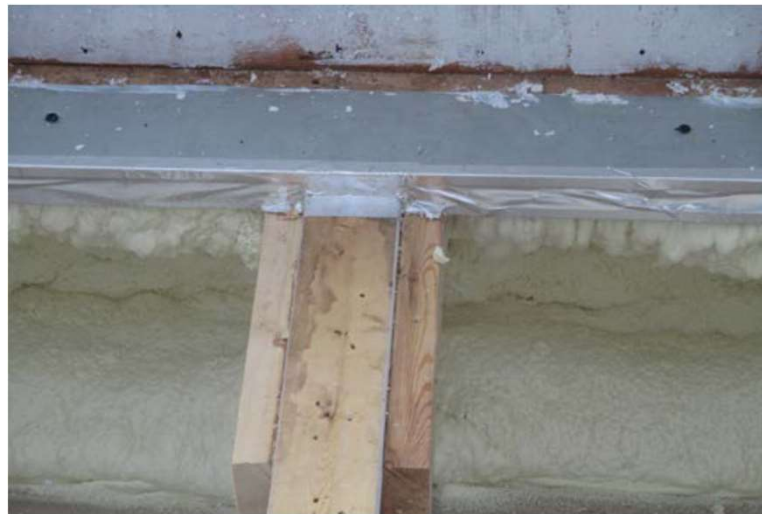
- **Design/Construction Challenges**
  - Importance of continuous vapor/air barrier transition between roof and exterior walls.
  - Designed U-shaped sheet metal to wrap around structural roof deck edge.

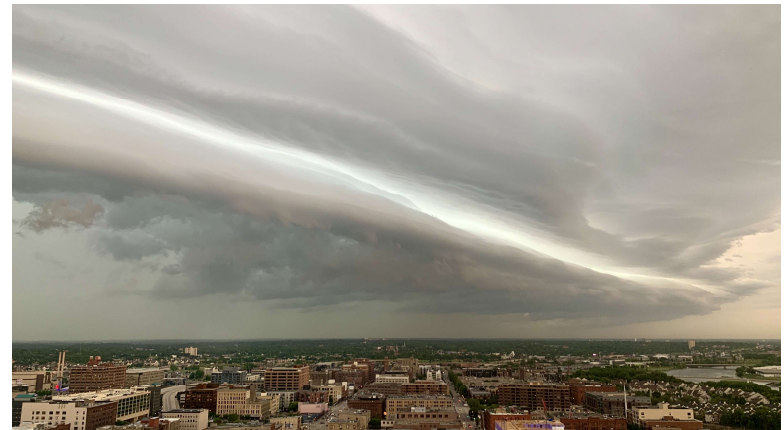
- **Design/Construction Challenges**
  - Risk of bad weather occurring when roof was removed/exposed.
  - Perimeter work was performed first, small areas exposed at one time which could be covered quickly if needed due to threatening weather.

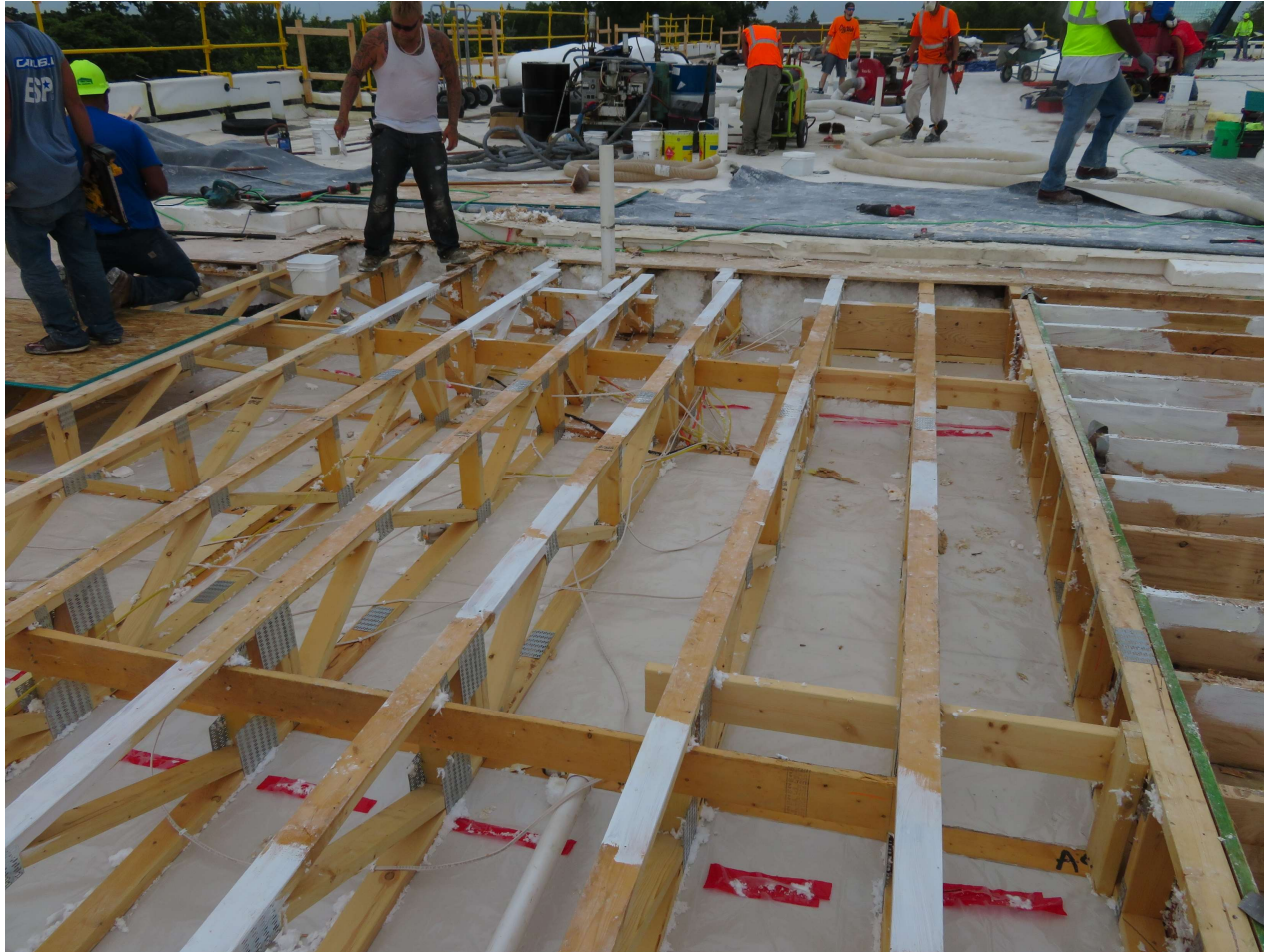
Mold remediation paint

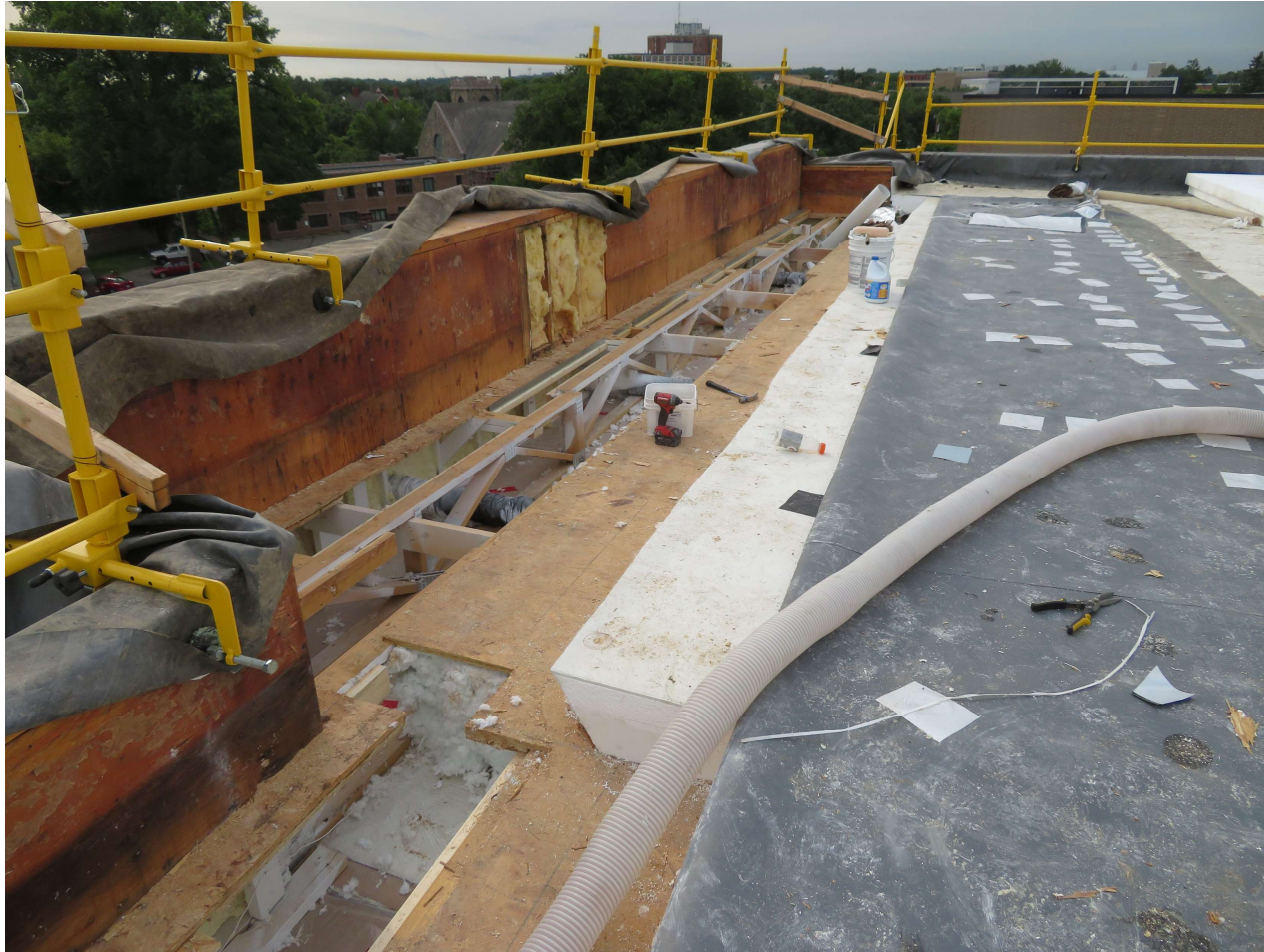
Typical work at roof perimeter

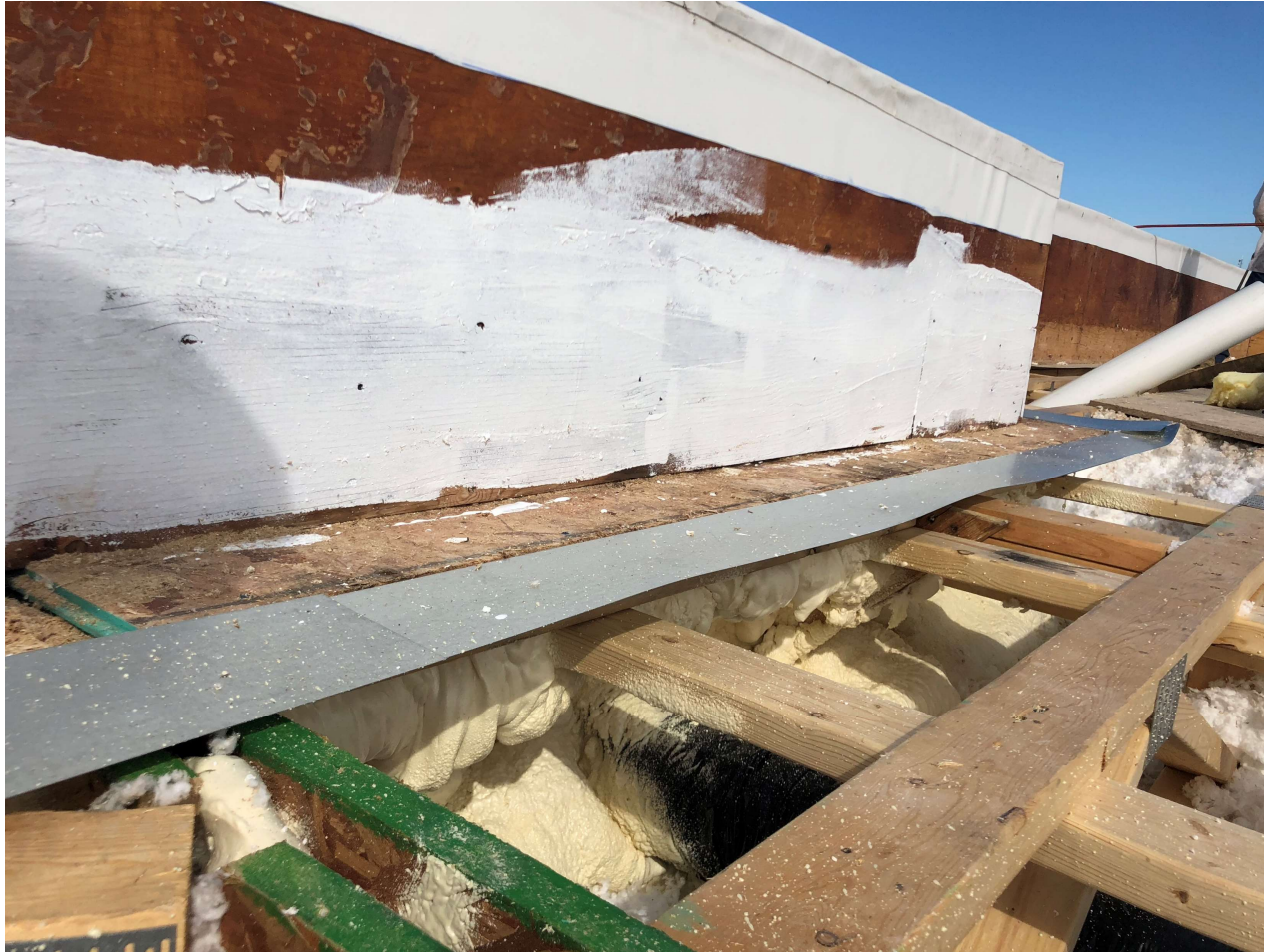
Z-shaped vapor/air barrier transition metal

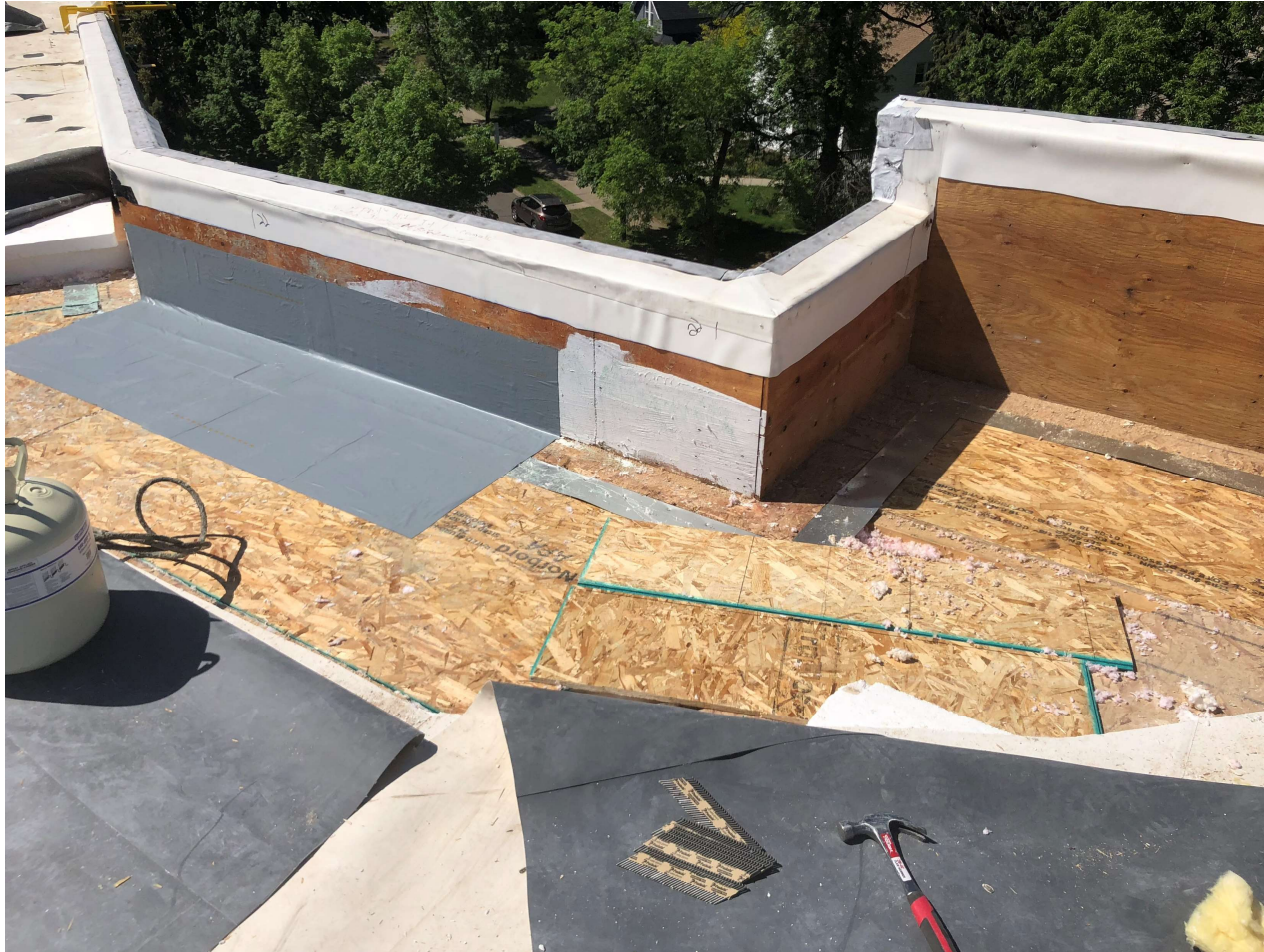
Roof vapor/air barrier at roof perimeter

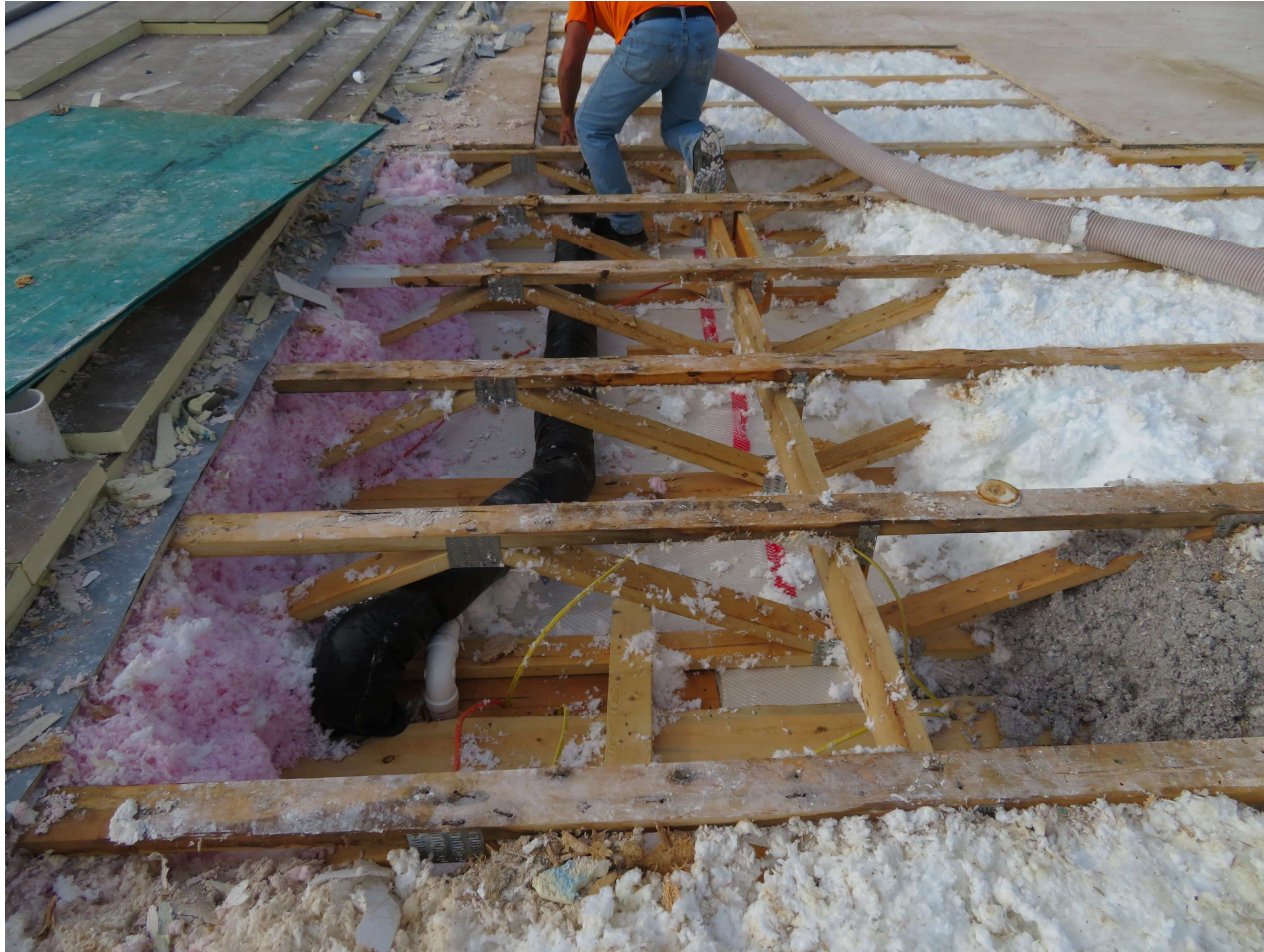
Blown-in insulation
